Technical Note

FULL-SCALE OVERTOPPING TESTING OF HYDROTURF® ADVANCED REVETMENT TECHNOLOGY

STEADY STATE OVERTOPPING TESTING

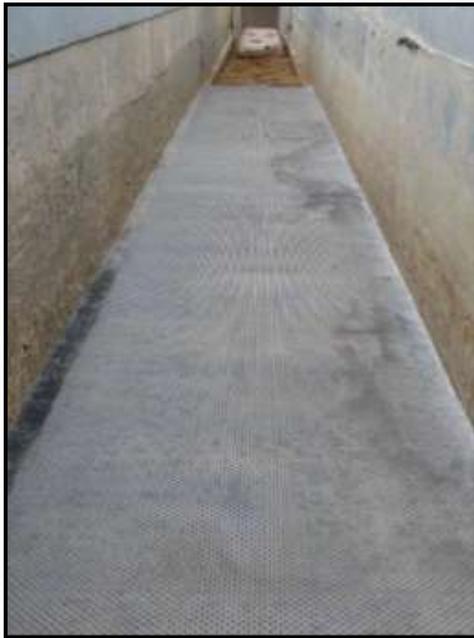
Figure 3. Structured Geomembrane Installation

The HydroTurf Revetment System was installed in general accordance with Watershed Geosynthetics installation guidelines in a flume at a 2H:1V (horizontal:vertical) slope. Installation occurs in four steps. Initially, a 1-foot thick layer of a sandy-loam subgrade was placed and compacted in the flume as presented in Figure 2. Second, a continuous sheet of the structured geomembrane was placed on the subgrade as presented in Figure 3. This geomembrane serves as the underlayer of the system. Third, the engineered synthetic turf was placed on the geomembrane. A horizontal seam was intentionally placed in the synthetic turf layer near the bottom of the flume. The purpose of the seam was to test seam strength under high flow velocity and shear stress conditions. The seam consisted of two sections of synthetic turf which were heat-bonded together using equipment similar to that used for field installations. The fourth step in testing preparation was applying approximately a ¾-inch thick layer of dry HydroBinder® into the fibers of the synthetic turf. The dry mixture was placed using a drop spreader and broomed against the turf grain to pull the fibers up through the infill. The HydroBinder infill was then hydrated by applying a light spray of water until saturation. The completed installation of the HydroTurf® System is shown in Figure 4.

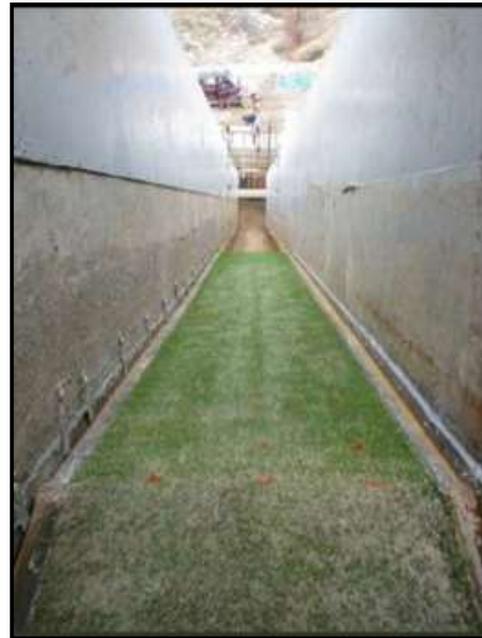
Figure 4. Installed HydroTurf® System

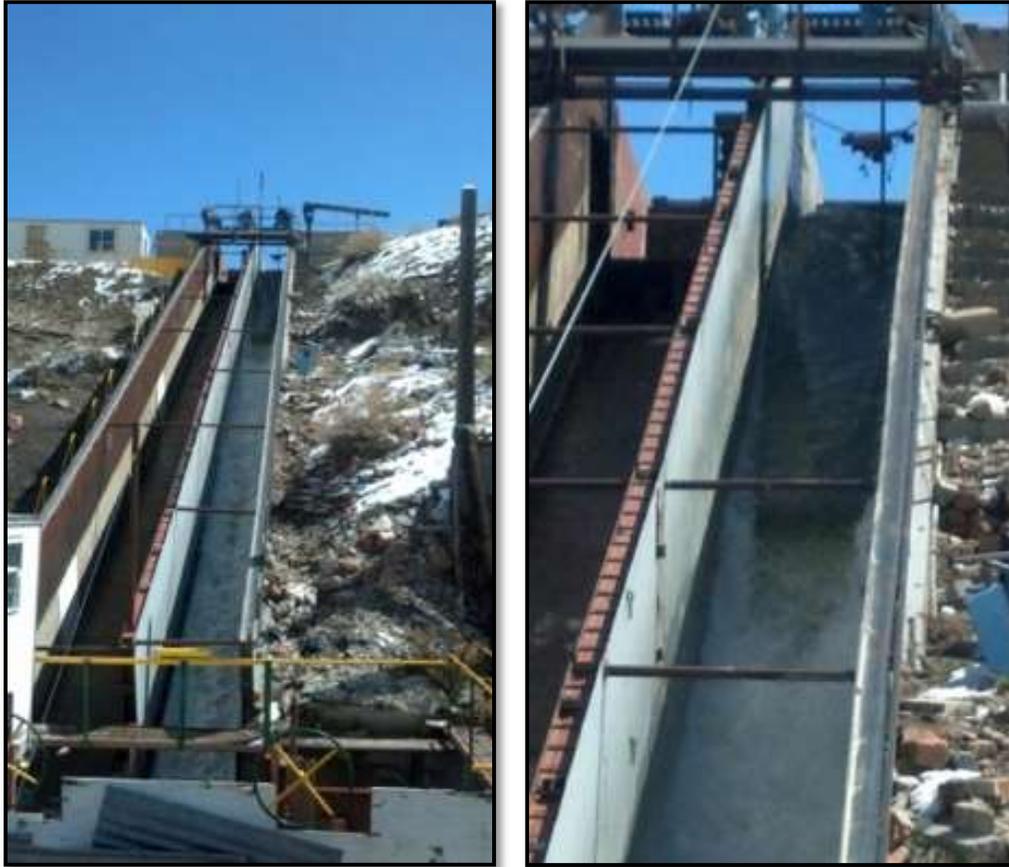
Figure 6. HydroTurf® Steady State Overtopping Testing at CSU

the embankment flume was inspected. The system and underlying soil were determined to be intact. CSU reported stable performance at velocity values of 40 ft/s. Since no instability, deformation, loss of intimate contact or damage to the system occurred, and since no erosion of the underlying subgrade occurred; the reported velocity is not a maximum performance threshold. A summary of these results is shown in Table 1. A profile of the testing section is shown in Figure 5, and photographs of testing are shown in Figure 6.

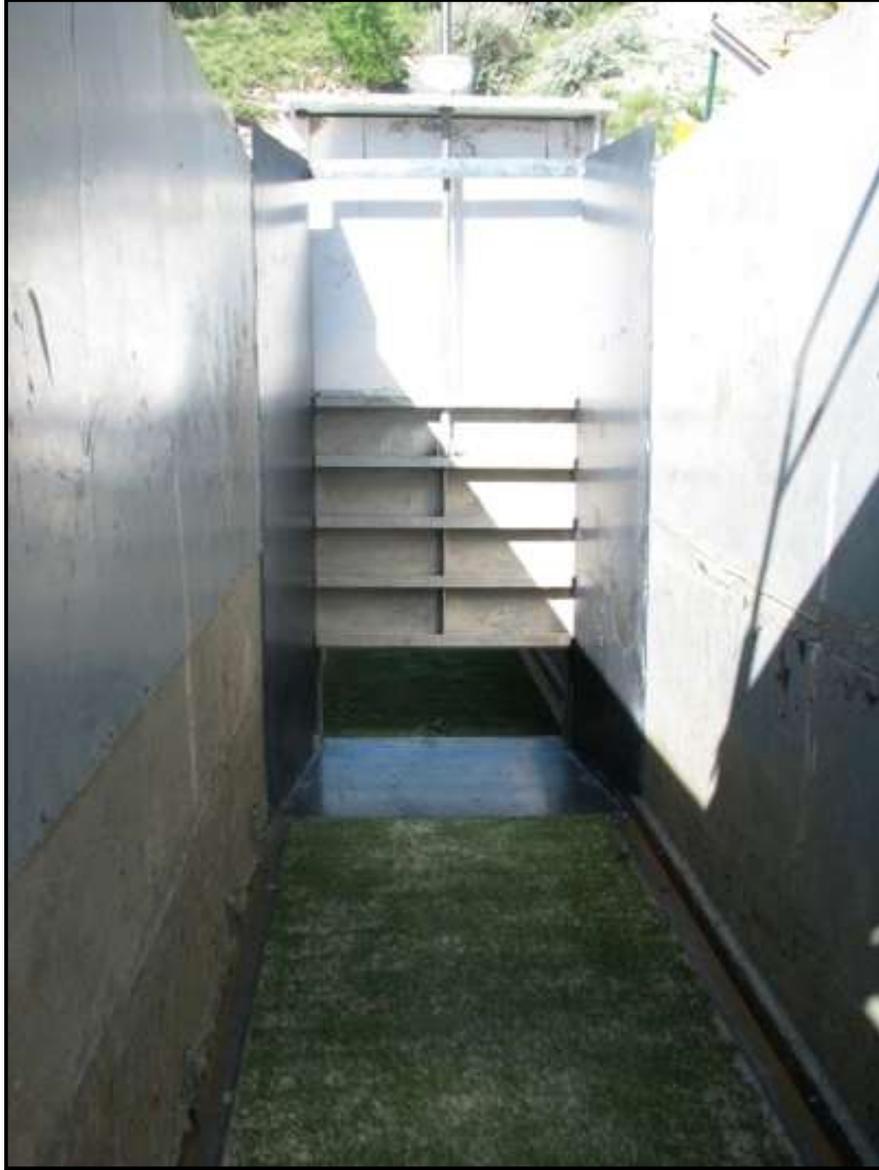
Figure 8. Hydraulic Jump Testing Sluice Gate Installation

Since there is no standard test method for measuring hydraulic jump, CSU developed a test program to adequately quantify the performance of HydroTurf® under a series of hydraulic jumps. A manually operated vertical sluice gate was installed approximately 22 feet from the top of the embankment to create a hydraulic jump on the HydroTurf as presented in Figure 8. The gate was placed and operated to induce a hydraulic jump on the lower one-third of the installed System. A profile diagram of the hydraulic jump test configuration is presented in Figure 9.

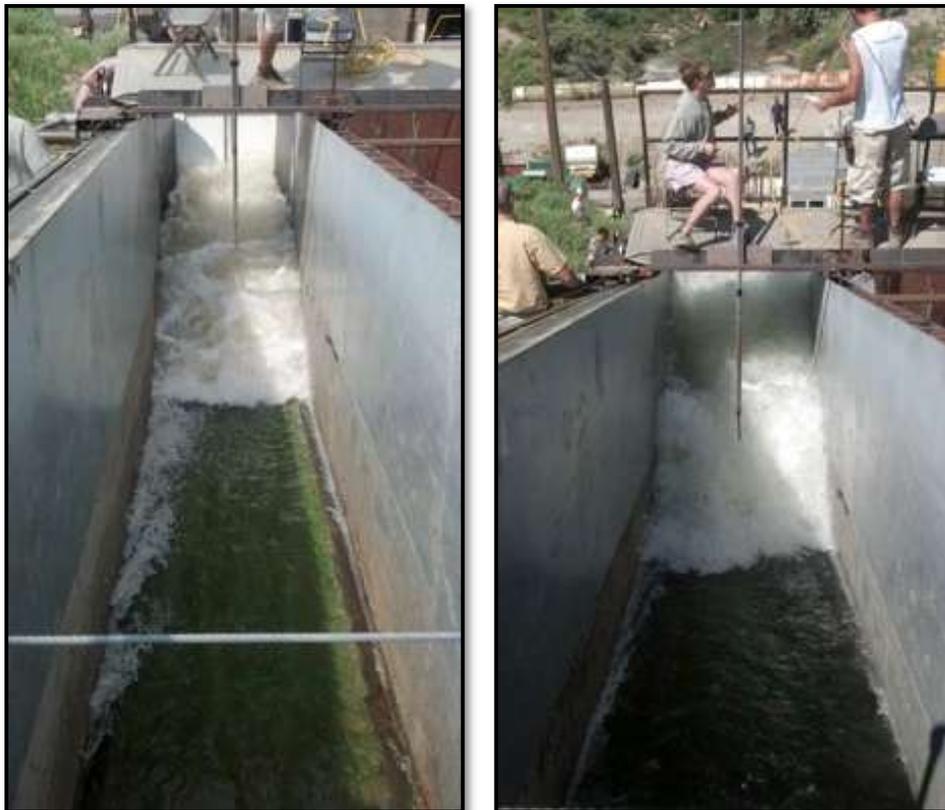
Figure 10. HydroTurf® Hydraulic Jump Testing at CSU

A hydraulic jump test consisted of a minimum of 1.5 hours of continuous flow at each overtopping depth (1.5, 3.0, and 5.0-foot overtopping depths). Measurements of water surface elevation were taken at the gate and at 2-foot intervals upstream along the centerline of the slope to the upstream extent of the hydraulic jump. After at least 30 minutes of flow for a specific hydraulic jump, the sluice gate was adjusted to extend the jump further upstream. The procedure was repeated for three hydraulic jumps at each overtopping depth. Photographs of the hydraulic jump testing are shown in Figure 10.

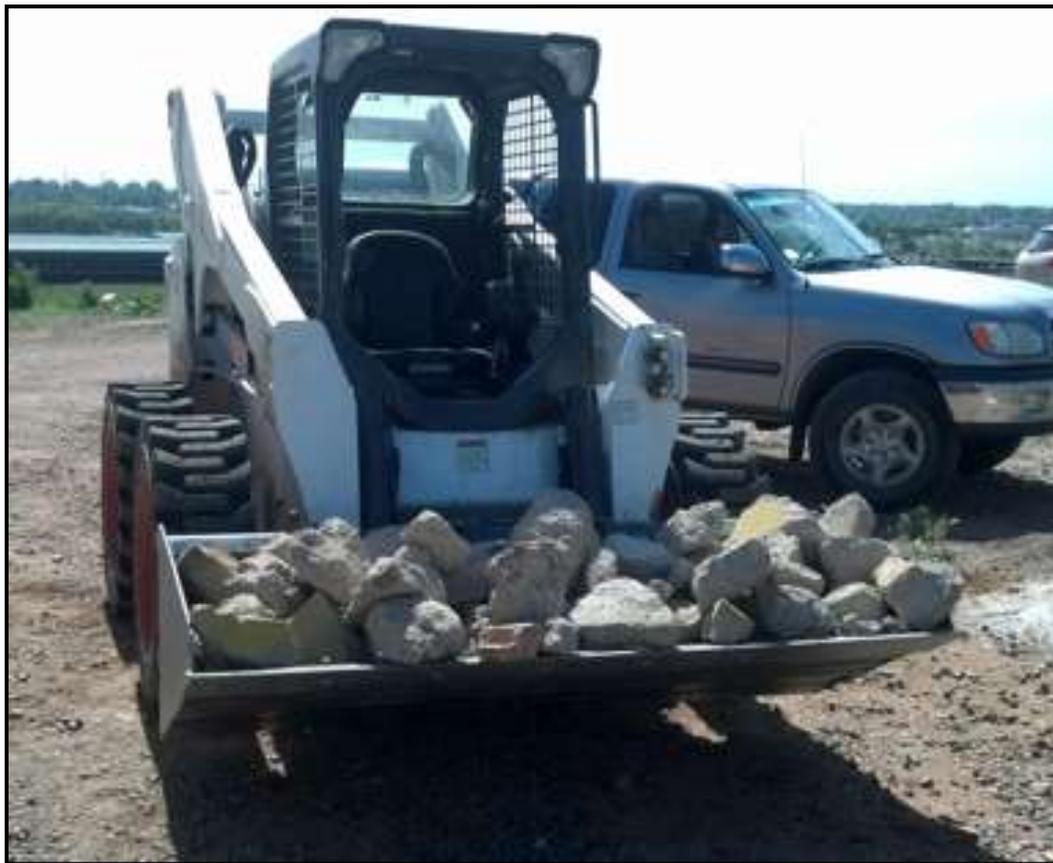
Figure 14. Concrete Rubble for HydroTurf® Testing

The evaluation was conducted by increasing flow until an overtopping depth of 5.0-foot was achieved. A Bobcat® S850 front-end loader was filled with broken, angular concrete rubble ranging from 3 to 15 inches in diameter as presented in Figure 14. Two full buckets of concrete rubble were dropped onto the HydroTurf from a height of approximately 12 feet near the embankment top as presented in Figure 15 and Figure 16. The concrete debris created a few minor surface impressions at the location of the 12-foot drop, but the integrity of the HydroTurf was not compromised and there was no observed damage to the system downstream of the drop location. No instability, loss of intimate contact, or erosion was observed.

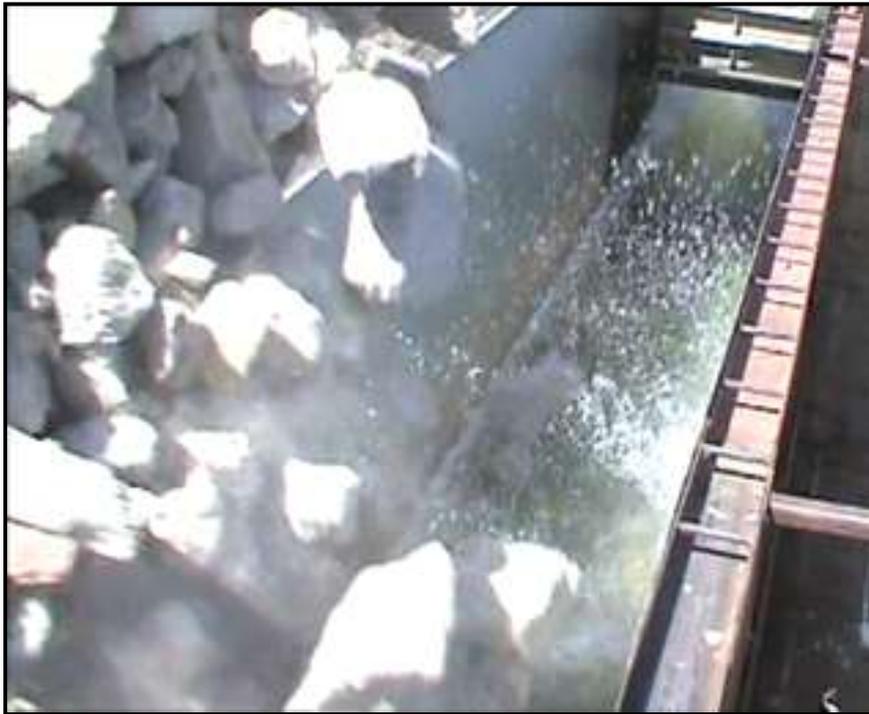
Figure 16. Heavy Debris Load Evaluation (Concrete Rubble)

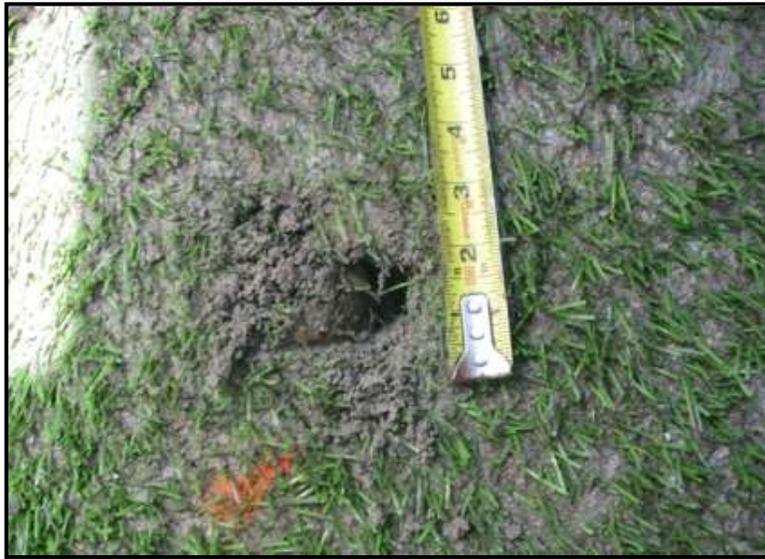
Figure 17. Intentionally Damaged HydroTurf®, Pre-test

HydroTurf® performance in a damaged state was also evaluated. A pick axe was intentionally driven through the HydroTurf and approximately 6-inch into the underlying sandy-loam subgrade. Figure 17 presents a photograph of the pick axe puncture. Testing was subsequently performed at 3 and 5-foot overtopping depths for a duration of 1 hour each (total of 2 hours). No instability or discernible erosion was observed.

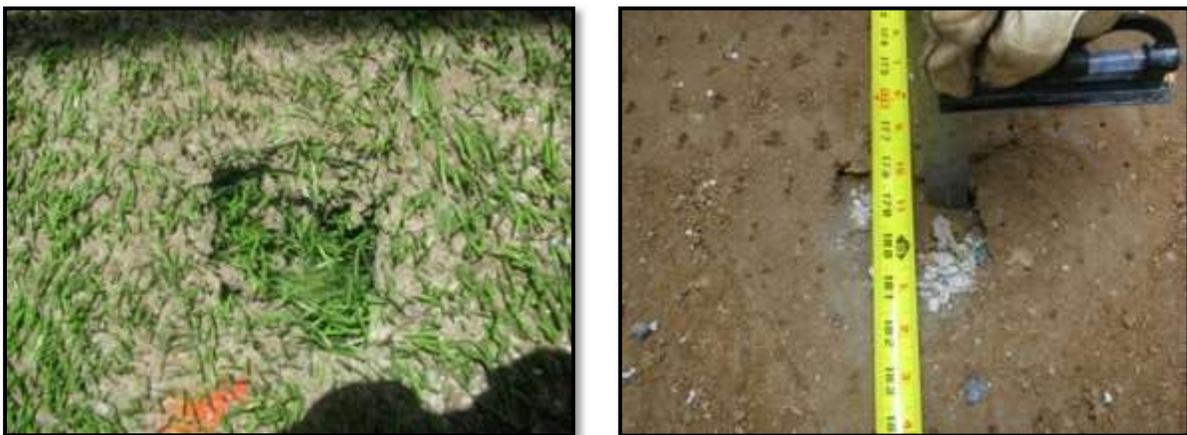
**Figure 18. Intentionally Damaged HydroTurf® Performance:
System Surface and Sub-grade, Post-test**

Following removal of the HydroTurf, the subgrade was inspected. There was no erosion, the initial hole had closed, and the entire embankment subgrade showed no signs of erosion. Figure 18 presents the pick axe hole at the conclusion of testing and after the system was removed.

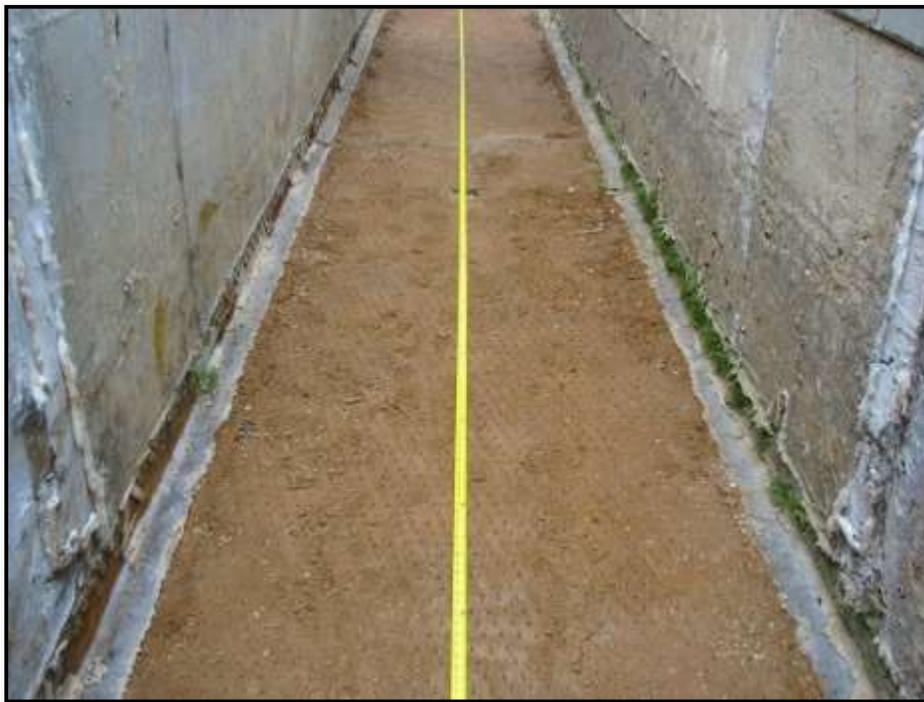
Figure 19. HydroTurf® Soil Subgrade, Post-test

The test program also demonstrated the ability of HydroTurf to withstand hydraulic loads caused by hydraulic jumps dissipating as much as 30 horsepower per foot of width. Qualitative testing demonstrated the ability of HydroTurf to withstand impact and abrasion caused by large debris, as well as withstand puncture damage. Instability or failure of the system did not occur, and erosion of the subgrade did not happen. *Therefore, the HydroTurf® Revetment System was not tested to its performance threshold.* A photograph of the condition of the soil subgrade post-test is presented in Figure 19.
