Innovative Geosynthetic Revetment System to Prevent Erosion under High Flow Conditions

Abstract

This paper defines the components of the CEST; describes the testing facility and procedures; provides an explanation of the preparation of the test trays; and reports the results. Also, a case study is presented in which CEST was used on a steep down chute application at the Grouse Creek Mine in Idaho.

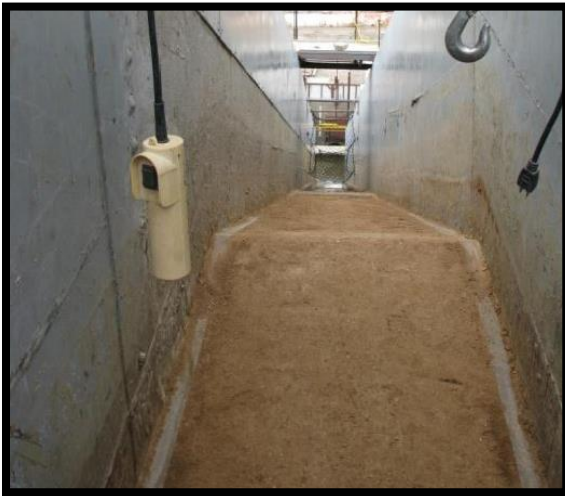
Installation and preparation of the CEST test sample was completed in general accordance with ASTM D7277-08. Subgrade soil material (sandy loam) was placed in the flume in order to simulate an earthen embankment. It was compacted in two equal 6 in (15.2 cm) lifts. Target compaction was achieved and verified between 87 percent and 93 percent of Standard Proctor (ASTM D698) density. Figure 3 presents a photograph of the embankment following soil compaction.

**Figure 3 – Compacted
Subgrade in Bottom of Flume**

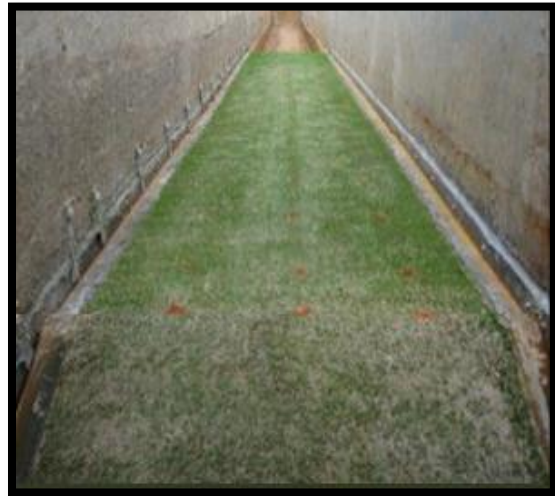
**Figure 4 – Completed
Installation of the CEST Prior
to Testing**

The structured geomembrane was placed in the flume as one continuous piece on top of the compacted soil subgrade. Next, the engineered synthetic turf was placed on the geomembrane. A horizontal seam was installed in the synthetic turf layer near the bottom of the flume in order to test its strength under high flow conditions. Two pieces of synthetic turf were heat-bonded together using equipment similar to that used for field installations (see Figure 6). Angle steel with a silicon bead was used to hold down the geomembrane and turf at the flume edge. Finally, the three-quarters inch (19 mm) thick layer of dry cementitious infill was applied into the fibers of the synthetic turf. It was hydrated by applying a light spray of water until saturation. Figure 4 shows the completed installation of the CEST test sample.

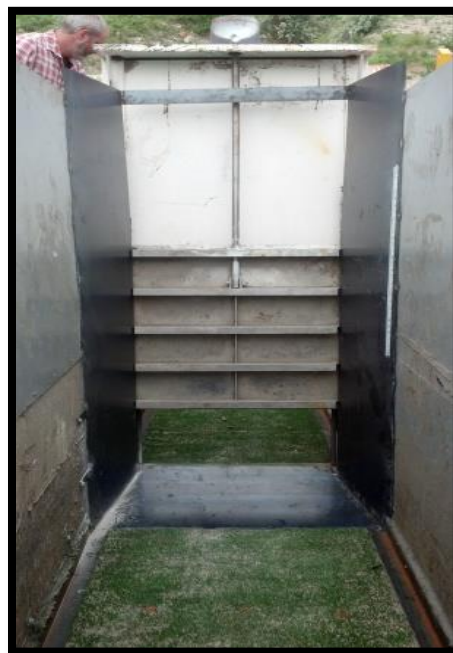
in (7.62 cm) sill plate. Figure 5 shows a section of the flume for the hydraulic jump testing with the approximate location of the gate. Figure 6 shows a picture of the gate installed in the steep overtopping flume.

Figure 6: Vertical Sluice Gate Installed in the Overtopping Flume

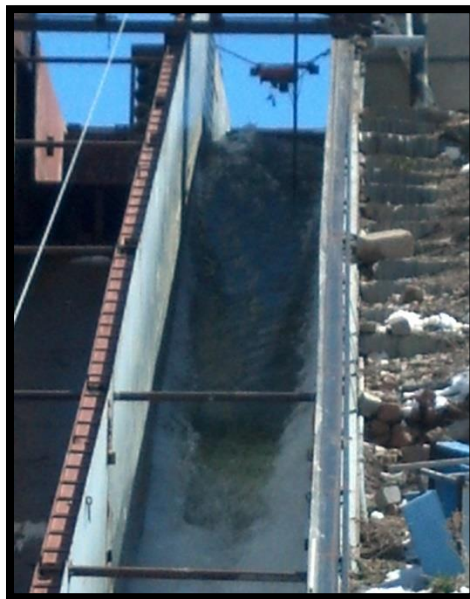
Figure 7: CEST Testing of 5 Foot Overtopping Depth in Process

A photograph of the steady-state testing at the 5 ft (1.52 m) overtop depth interval is presented in Figure 7.

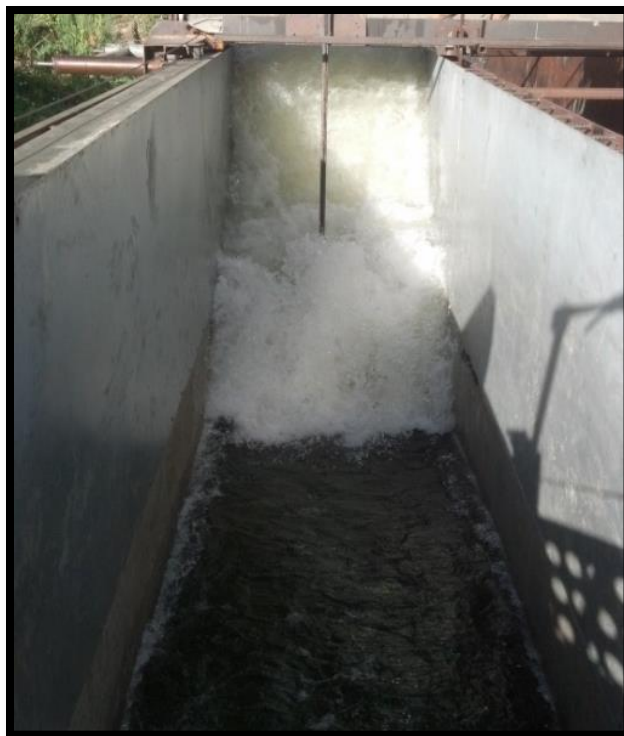
A photograph of the hydraulic jump testing is presented in Figure 8.

Figure 8: Hydraulic Jump Testing of the CEST

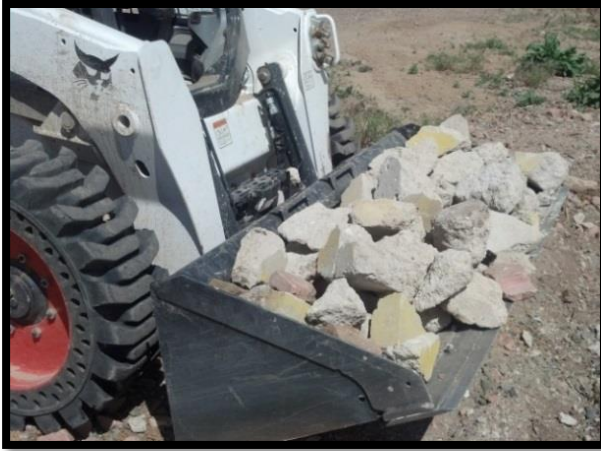
Broken, angular-concrete blocks, ranging in size from approximately 3 to 15 inches (7.6 to 38.1 cm) in diameter (see Figure 9), were dumped into the flume from a height of approximately 12 feet (3.7 m). Two bucket loads of concrete rubble were dumped into the flume. The flow was shutoff and the embankment was inspected. Figures 10 and 11 show the concrete debris dropping into the flume.

Figure 9: Concrete Debris

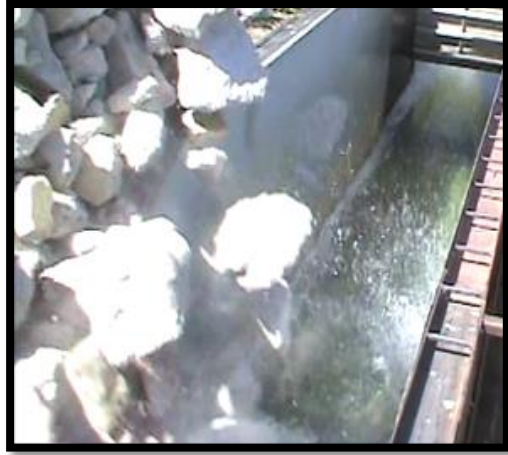
Figure 10: Concrete Debris
Being Dropped into the
Flume

Figure 11: Concrete Debris Being Dropped into the Flume

Dam spillways, large channels and steep channel chutes at mine sites have the potential to carry large debris. In order to assess the resilience of the CEST to impact and abrasion from debris loads, a qualitative test was performed. Large, angular-concrete rubble was dropped from a height of 12 ft (3.7 m) into the flume during an overtopping flow. After the two loads of concrete rubble were dropped and traveled down the flume, the flow was turned off and the CEST was inspected. The inspection revealed that the debris caused a few minor surface impressions (crack 1/16 in wide 3 to 4 in long) in the cementitious infill at the location of the 12 ft (3.7 m) drop (top of the flume). The integrity of the CEST was not compromised at the location of the drop, and there was no observed damage to the system downstream of this location. No instability, loss of intimate contact, or erosion was observed. The CEST performed well against the heavy debris loads.

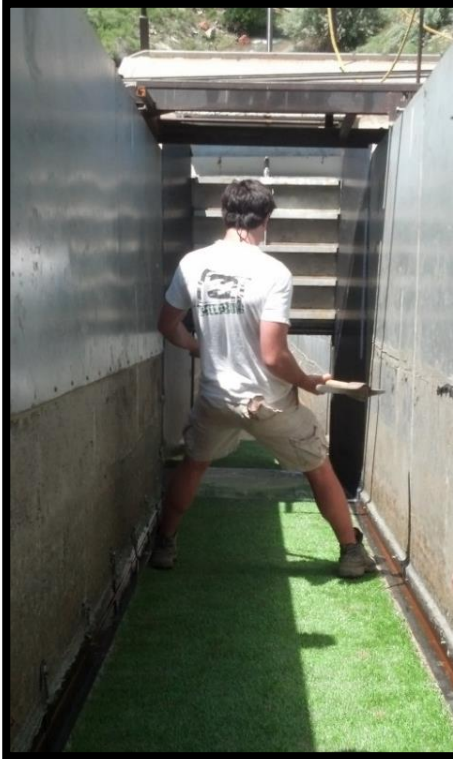
After inspection of the CEST from the large debris testing, a hole was driven through the CEST and approximately 6 in (15.2 cm) into the underlying subgrade, using a pickaxe. The system was tested at an overtop depth of 3 feet (0.91 m) for one hour. Then the flow was increased to an overtopping depth of 5

feet (1.52 m) for another one hour period. A photograph of the hole being created is shown in Figure 12, and a photograph of the hole prior to testing is shown in Figure 13.

Figure 12: Pickaxe Being Used to Create an Intentional Hole

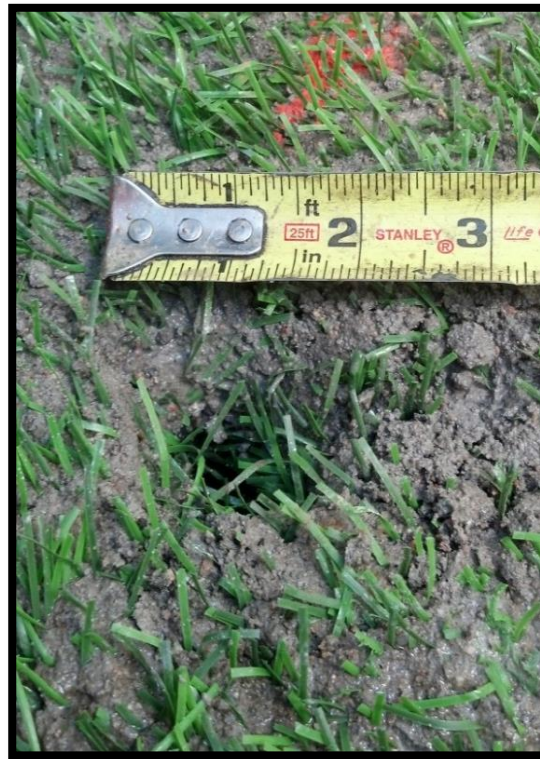
Figure 13: Intentional Hole in the CEST Prior to Testing

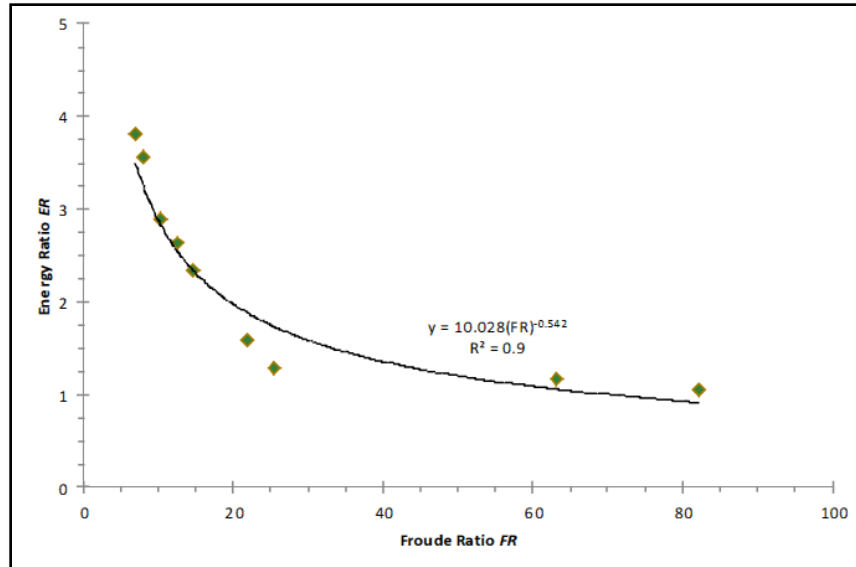
Even though a hydraulic jump performance threshold was not reached for the CEST, curves were still created for the Energy and Froude Ratios (See Figure 14) and Power Dissipation as a Function of the Energy at the Entrance to the Jump (See Figure 15). These curves represent a known performance level for the CEST but do not represent a performance threshold. Note that the CEST withstood hydraulic loads caused by hydraulic jumps dissipating 30 horsepower per foot of width (22.4 kW).

Figure 14: Energy Ratio as a Function of Froude Ratio for CEST

- The energy ratio versus the ratio of the upstream and downstream Froude numbers. The energy ratio is the energy lost in the hydraulic jump compared to the energy that would be lost in the same channel without a hydraulic jump.
- Hydraulic power versus the specific upstream energy for the hydraulic jump. Hydraulic power is the energy lost in the hydraulic jump, and the specific upstream energy is the entrance energy for the jump.

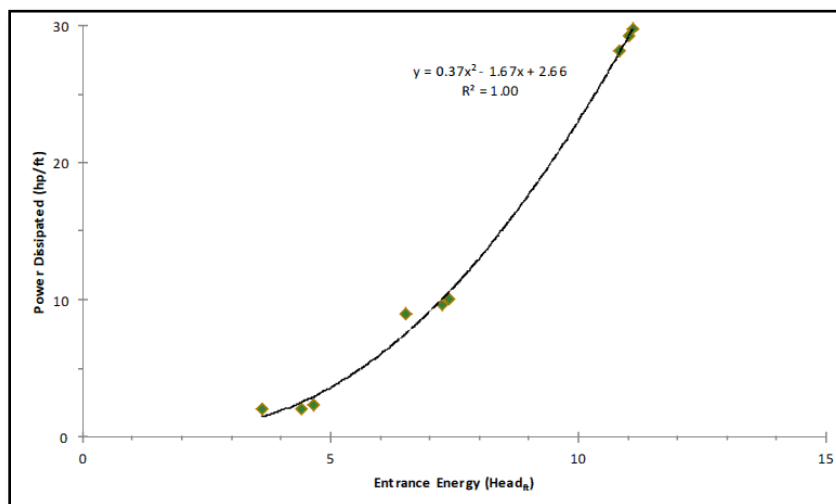
Figure 15: Power Dissipation per Foot of Width as a Function of Specific Energy at the Entrance to the Hydraulic Jump for the CEST

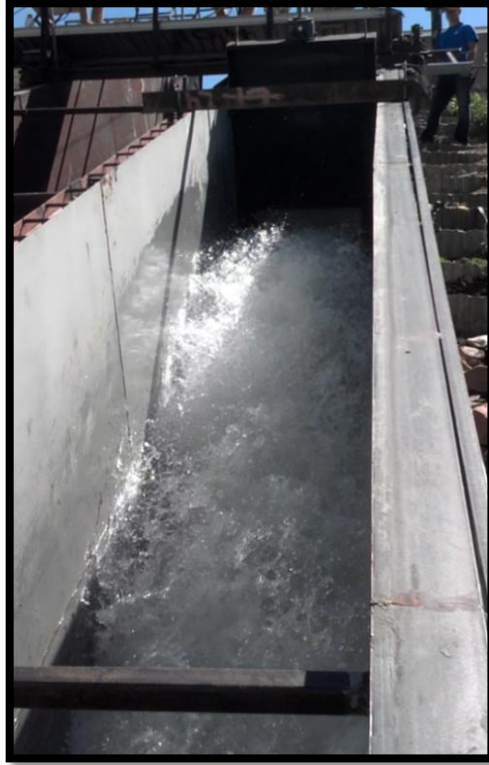
The vertical sluice gate used for the hydraulic jump testing had a small opening at the base. A pressurized “jet” of flow surged from under this gate out onto the CEST. A photograph of the “jet” flow is shown in Figure 16. Even though the extreme turbulence of the flow made it difficult to calculate the velocity precisely, a conservative estimate of the velocity was able to be made. It was estimated to be 35 fps (10.7 m/sec). There was no instability, deformation, loss of intimate contact, or damage of the CEST, and there was no erosion of the underlying highly-erodible subgrade caused by the “jet” of flow.

Figure 16: Pressurized “Jet” from Under the Sluice Gate Surging onto the CEST

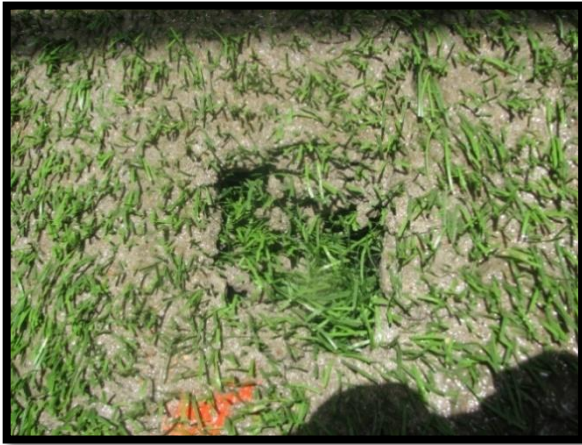
sandy-loam subgrade. Flow discharges were run at the 3 ft (0.91 m) and 5 ft (1.52 m) overtop depths for a duration of one hour at each depth interval. During the testing, it was observed that there was no instability, loss of intimate contact, or discernible erosion. After the testing, the CEST was inspected. It was noted that the hole was still intact and did not further unravel. The condition of the hole is shown in the photograph in Figure 17.

Figure 17: Intentional Hole after Testing

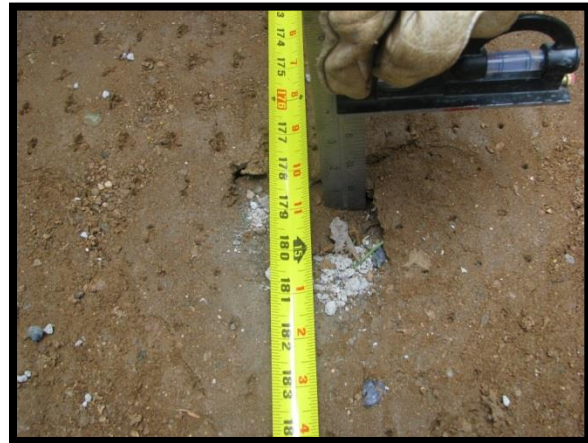
Figure 18: Soil Subgrade at Location of Intentional Hole after Testing

After the completion of the twenty hours of testing in the steady-state overtop facility, the CEST was removed, and the subgrade was inspected. There was no erosion of the subgrade at the location of the intentional hole. The hole closed in (see Figure 18). The velocity was calculated at the location of the hole in the flume to be 24.4 fps (7.4 m/sec). The CEST performed well after being subjected to puncture damage.

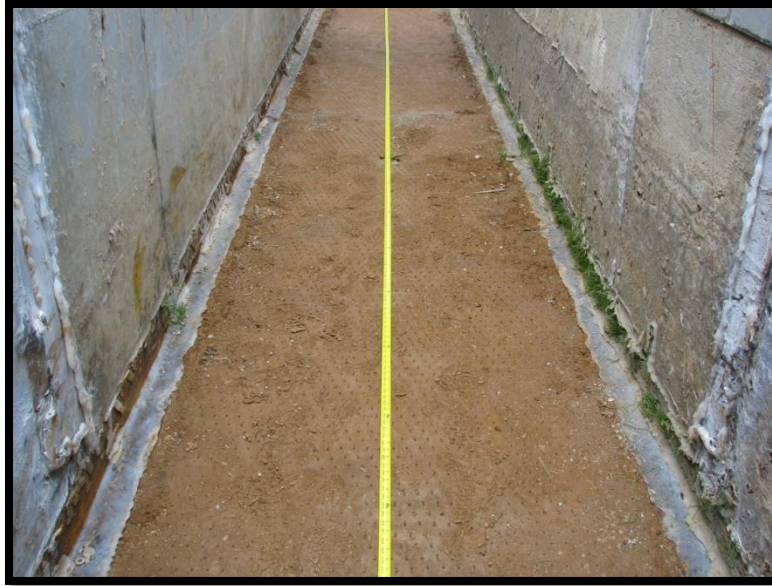
Also, the subgrade along the entire embankment showed no signs of erosion (see Figure 19).

Figure 19: Soil Subgrade of Embankment after Testing of the CEST

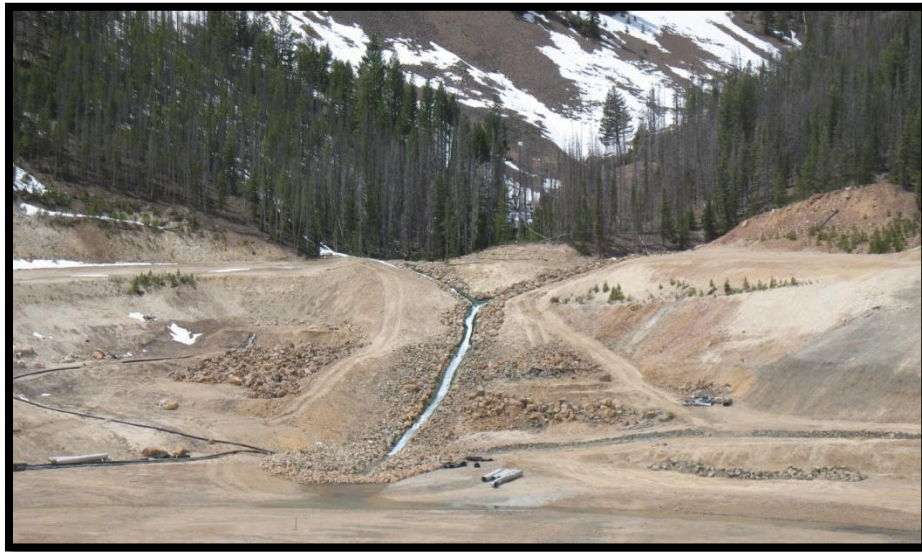
In 2011, a CEST System was selected for use as a channel-lining material for the last phase of restoration of Washout Creek. This trapezoidal channel design utilized a low-flow channel section lined with CEST. The low flow section was 8 ft (2.4 m) wide base with 2:1 sideslopes to a flow depth of 2 ft (0.6 m). The edges of the CEST lining were to be anchored under a 4 ft (1.2 m) high rock wall that would extend 7 ft (2.1 m) on either side of the low-flow channel. A photograph of the CEST channel used on the steep tailings pile is shown in Figure 20.

Figure 20: CEST Channel at the Grouse Creek Mine

Hydraulic calculations using Manning’s Equation indicate all flows, other than the 500 yr peak flow in the North Channel and Washout Creek Channel, would be contained within the CEST lined low-flow section with all flows contained between the design rock walls on either side of the low-flow section. Calculated design flow depths in the channel sections ranged from 1.78 ft (0.54 meters) in the South Channel with a slope of 15 percent to 3 ft (0.90 m) in Washout Creek with a channel slope of 25 percent. Corresponding flow velocities were 18.7 ft/sec (5.7 m/sec) and 34.8 ft/sec (10.6 m/sec), respectively. These calculated flow velocities within the 500 yr peak design flows would not exceed the values for the CEST as measured in the full-scale during the testing program conducted at CSU. Froude numbers for all flows were greater than 1 indicating supercritical flow in all three channel sections.
