Case Studies of Extreme Weather Performance of Engineered Turf Final Cover System

Ming Zhu, Ph.D., P.E.
Director of Engineering
Watershed Geo

March 10, 2020 | North Charleston, SC

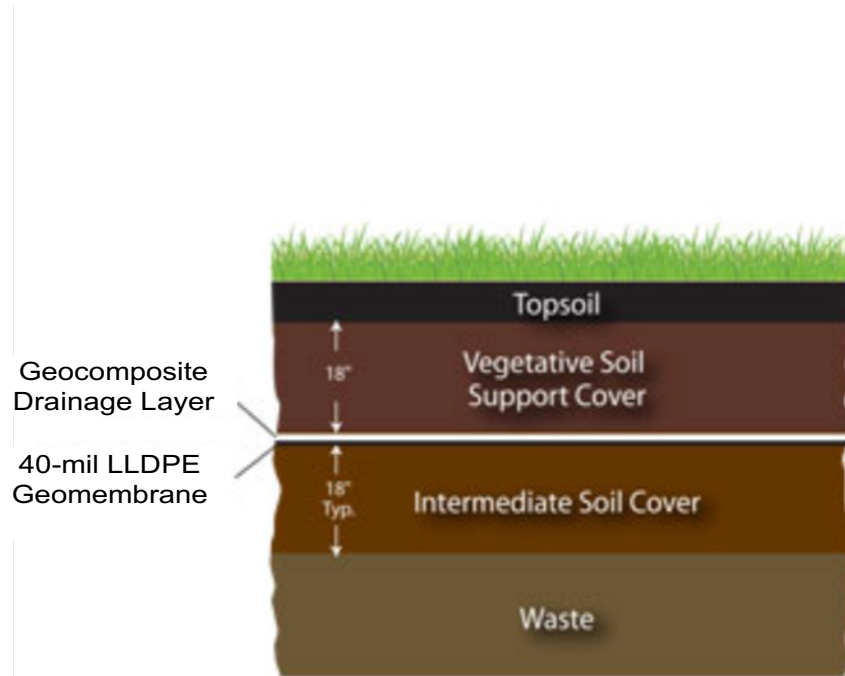
An Example of Traditional Soil Cover

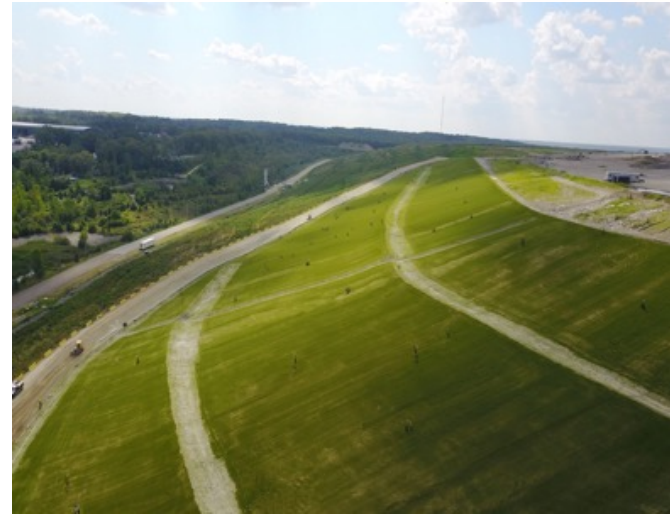
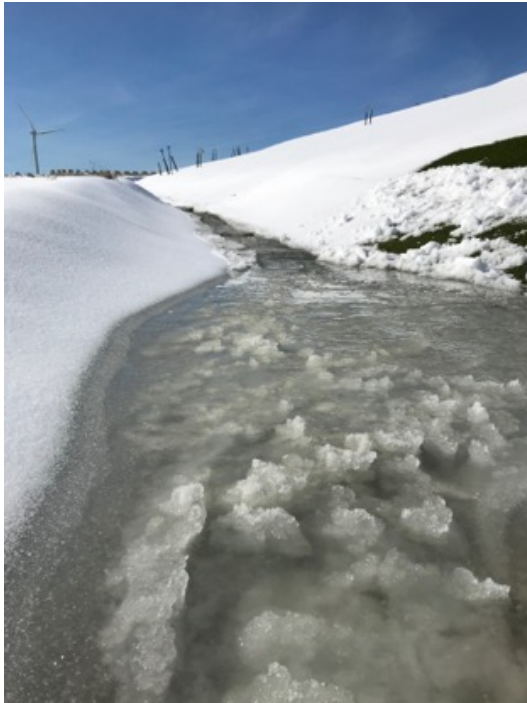
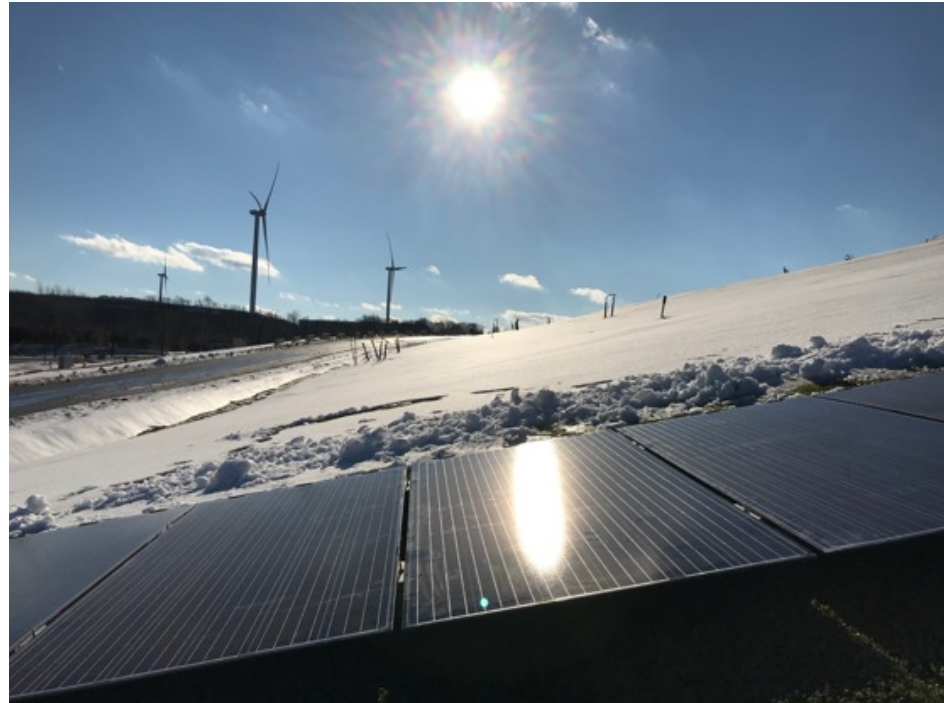
Central Landfill, Johnston, RI

Winter storm, Skylar, brought high winds and over a foot of snow in March 2019 as the third Nor'easter to strike the Northeast during that winter.

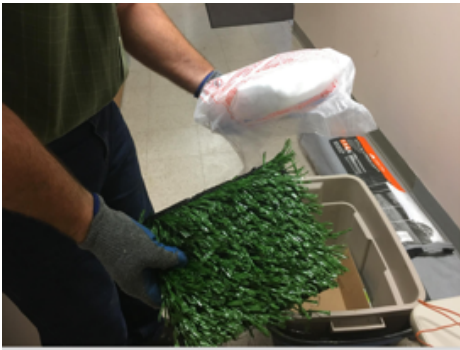
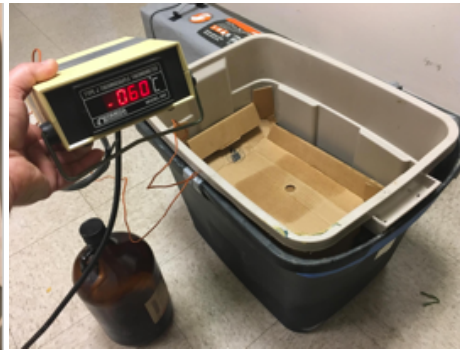
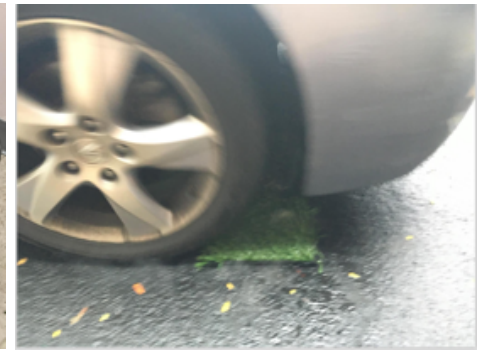
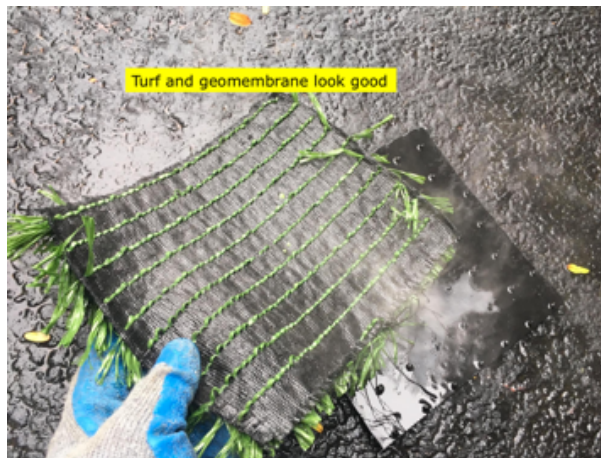
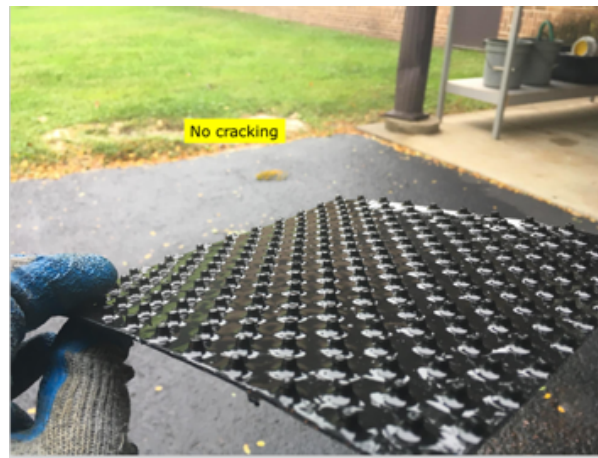
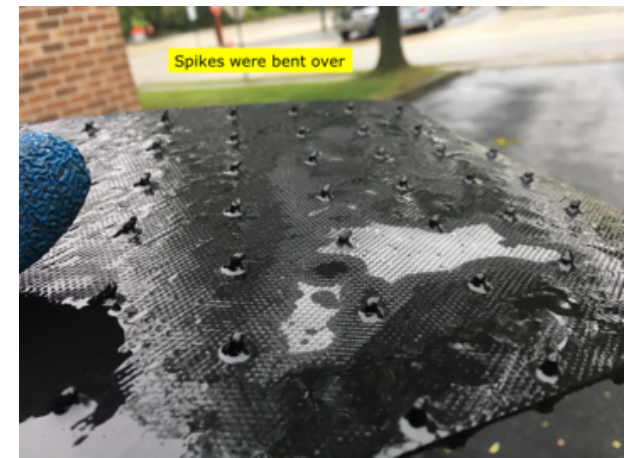
Deep Freeze Experiment by the Geosynthetic Institute (GSI)

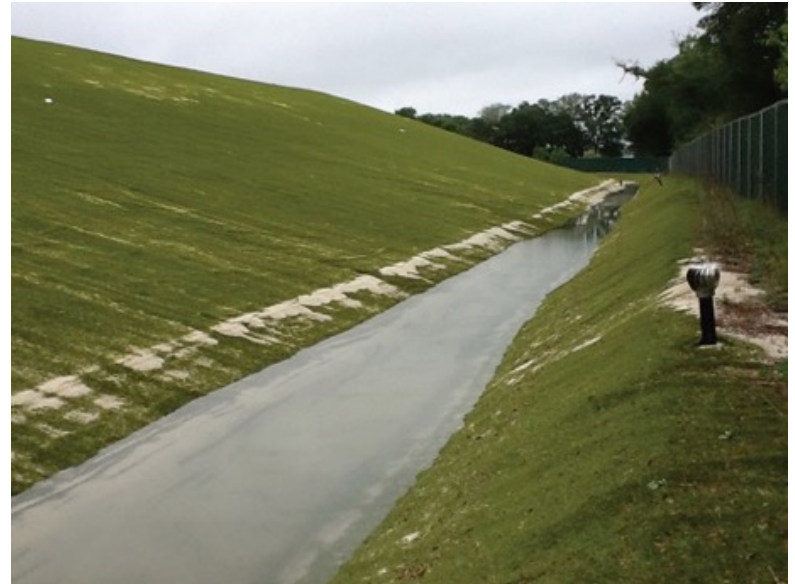
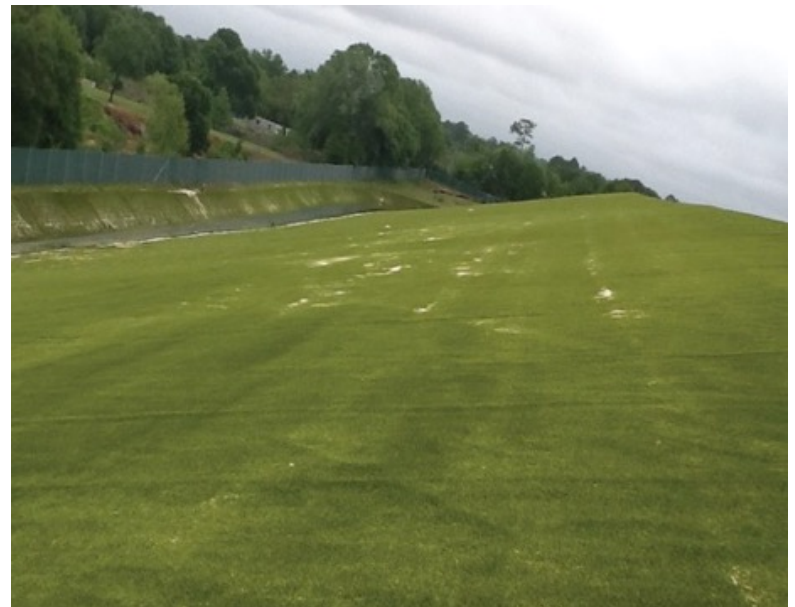
Saufley Field Road Landfill, Pensacola, FL

- ❖ The site received over 22 to 26 inches of rain in 24 hours on April 29th and 30th, 2014 (a 500-yr storm event).
- ❖ There was no impact on the surrounding community, no damage to report, and no immediate attention required.

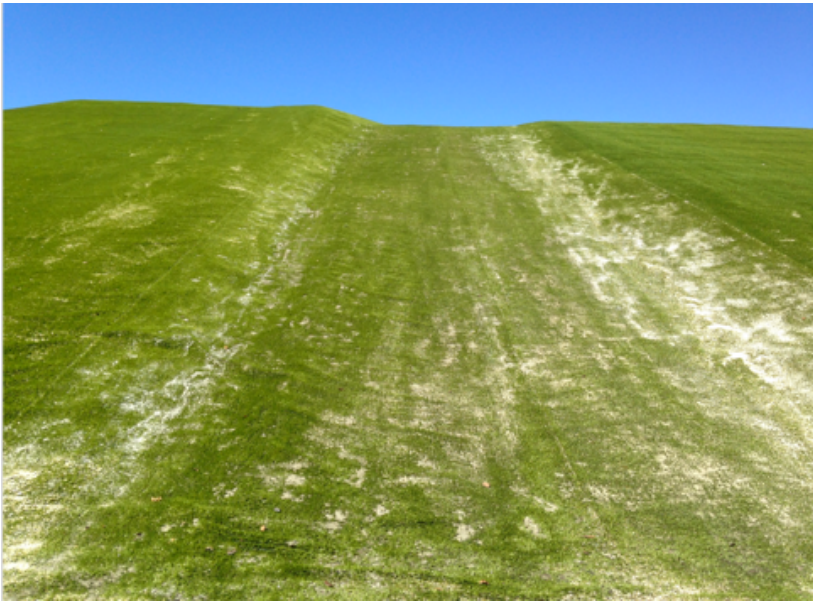
Engineered Turf Downchute with
Cementitious Infill (October 2014)

Comparison of Downchute Performance

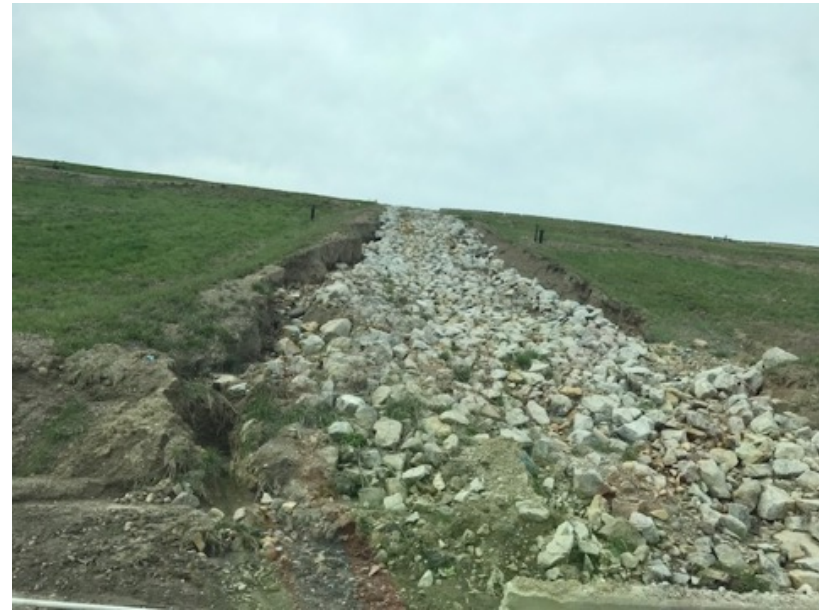
Typical Failure of a Rock Downchute
(from another landfill site; shown as an example)

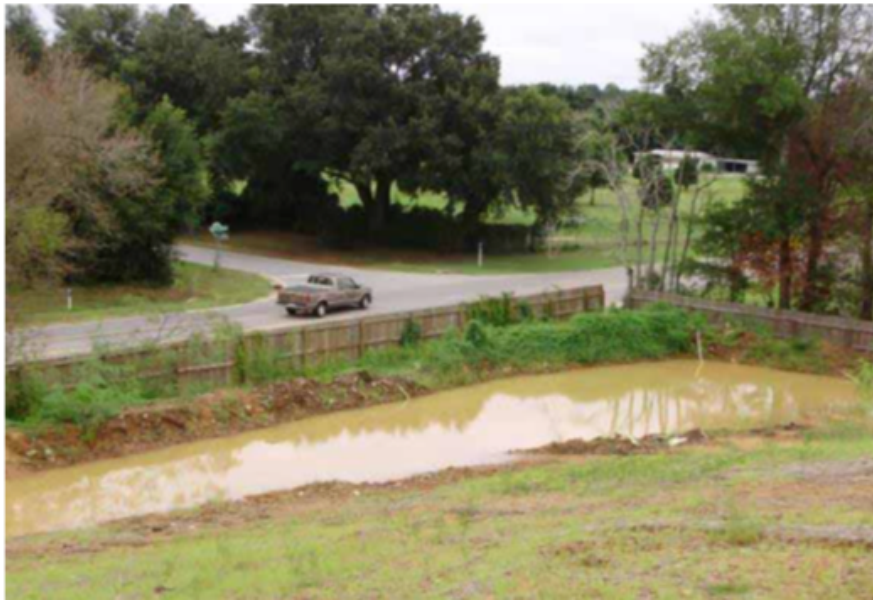
Before Installation of Engineered Turf Cover

Comparison of Runoff Quality

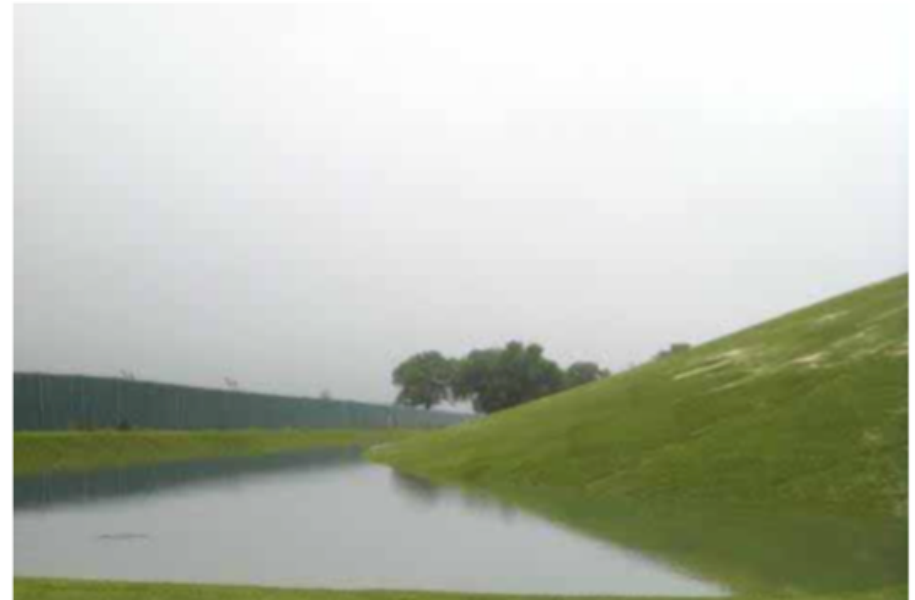
After Installation of Engineered Turf Cover

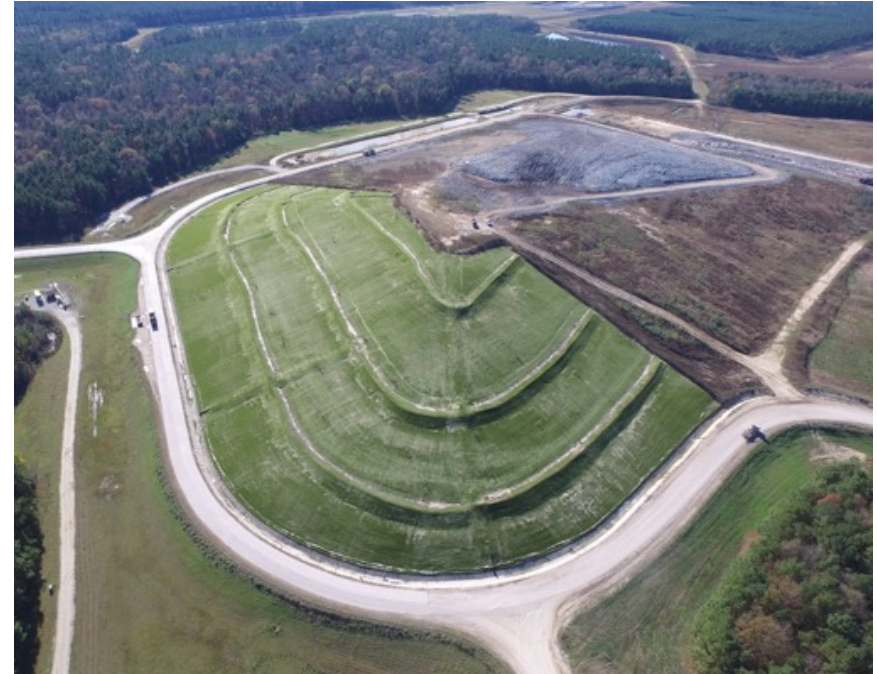
Berkeley County Landfill, SC

The Engineered Turf Cover survived ~26 inches of rain during a four-day period from October 1st to 5th, 2015 (1-in-1000 event).

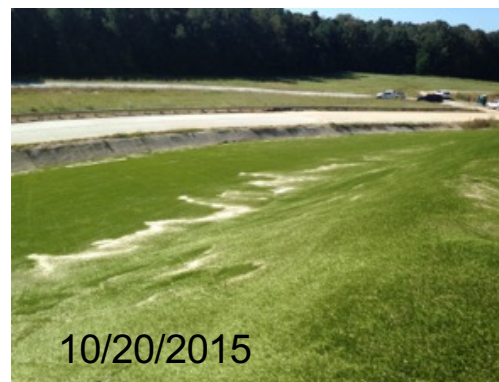
Engineered Turf Cover Area

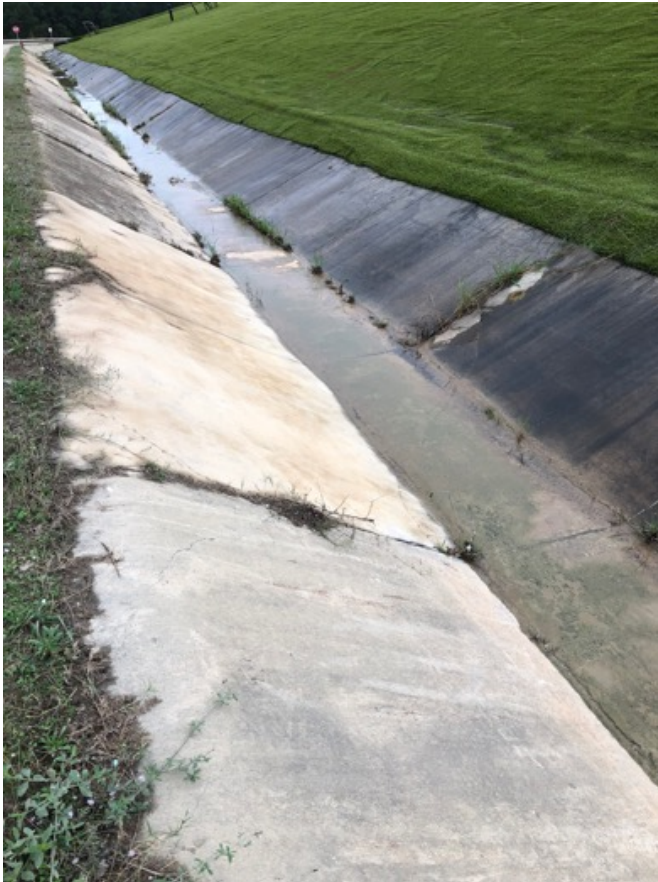
Engineered Turf Cover Area

Perimeter Channels (Nov. 2018)

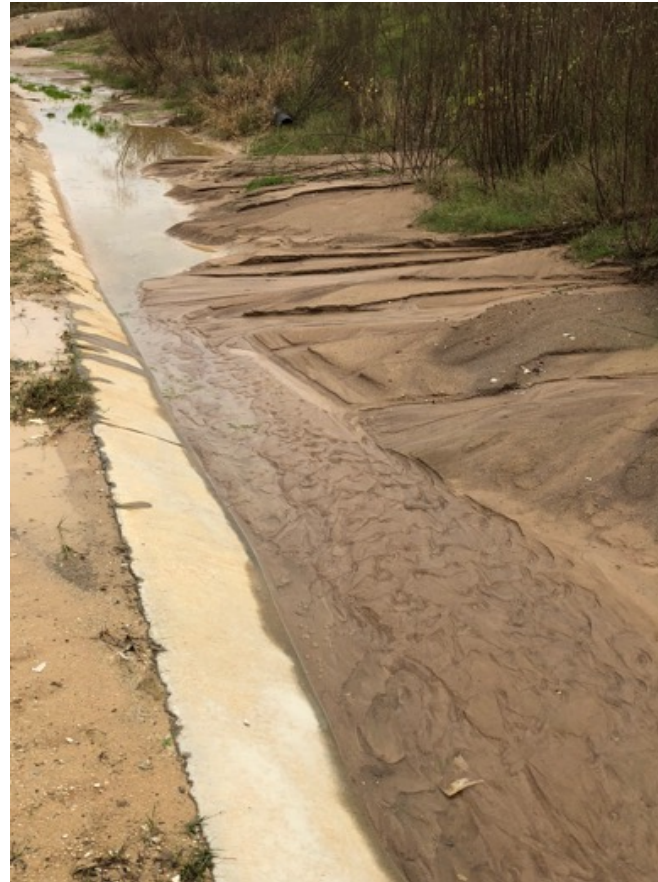
Soil Cover Area

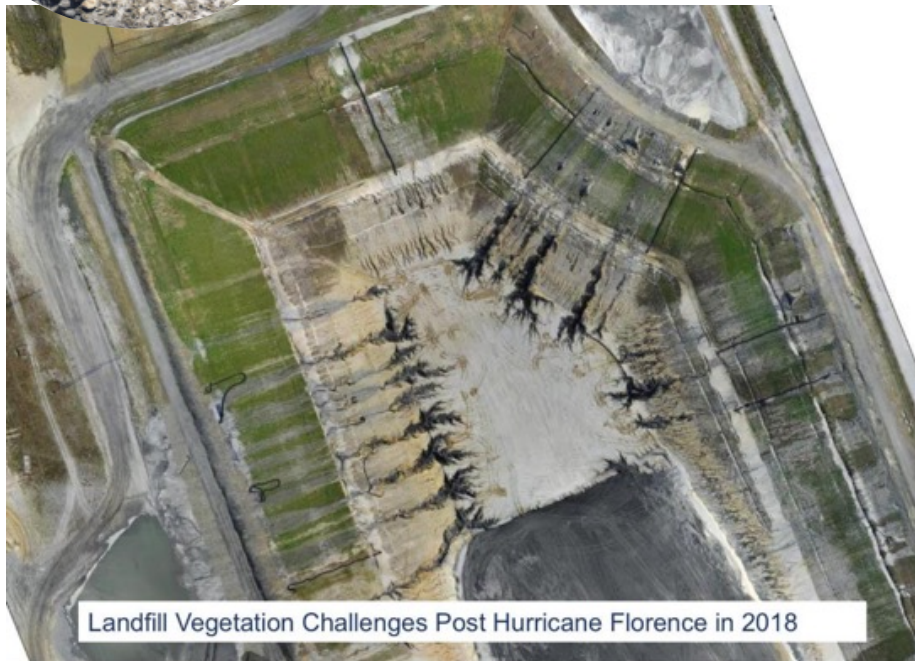
Interim Soil Cover
(after Hurricane Florence in 2018)

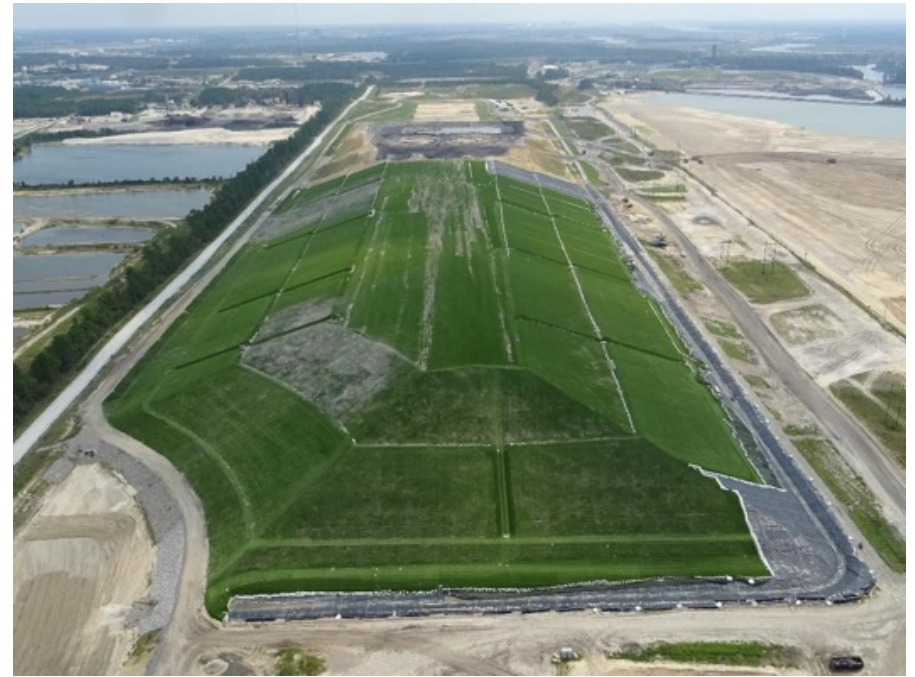
During Installation of Engineered Turf Cover
(after Hurricane Dorian in 2019)

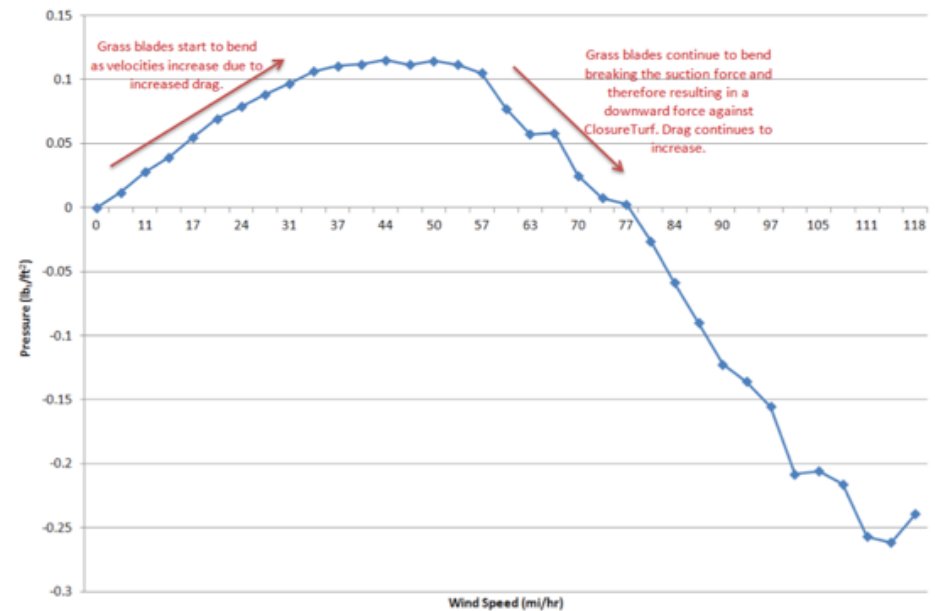
The measured uplifting force was less than the weight of the engineered turf and changed to downward force as the turf blades bent towards the ground by wind.

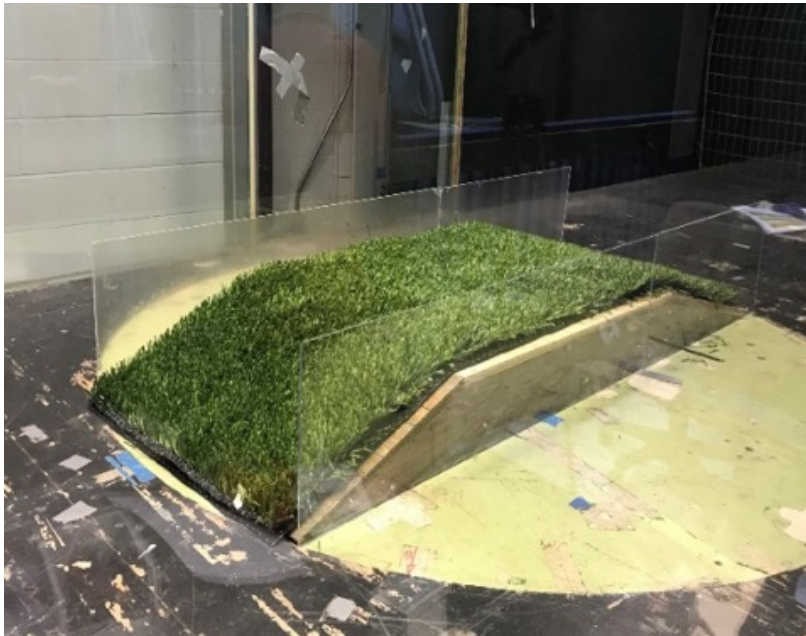
Wind Tunnel Testing at Iowa State University, 2018 - 2019

Wind pressure coefficient:

$$C_p = \frac{\Delta P}{0.5 \rho U(H)^2}$$

“+”: downward compression
“-”: upward lifting
