TECHNICAL NOTE

FULL-SCALE HYDRAULIC TESTING OF THE HYDROTURF® ADVANCED REVETMENT TECHNOLOGY

Extensive independent, 3rd party hydraulic testing has been performed at Colorado State University – Engineering Research Center (CSU) in Fort Collins, CO on the HydroTurf® Revetment System. This technical note describes the full-scale testing that was completed. The information presented in this technical note is as follows:

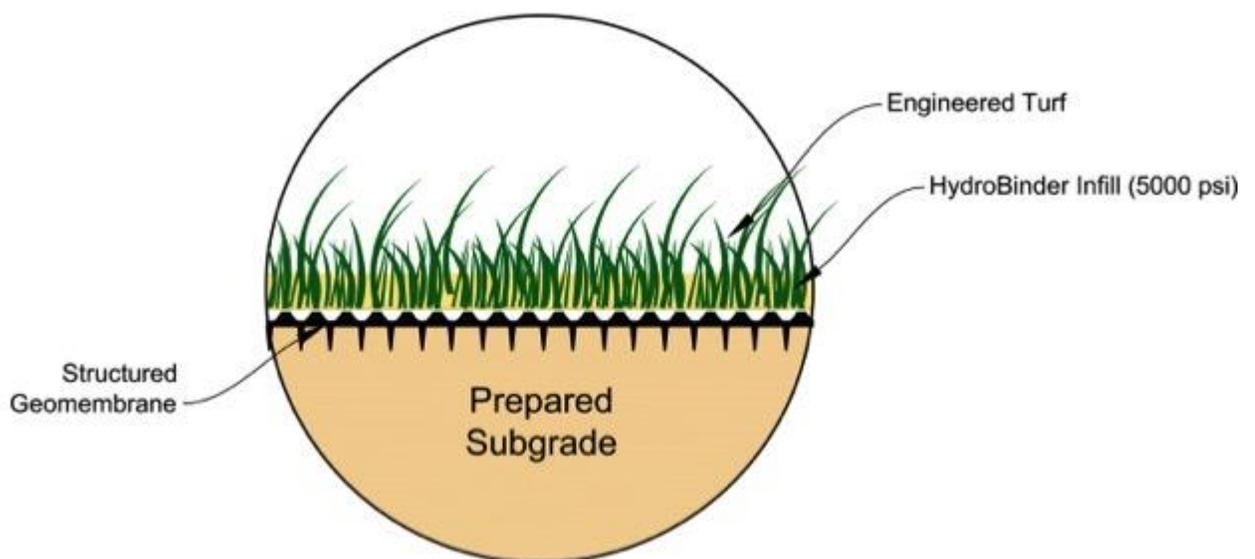
Figure 1 – Section of HydroTurf® Revetment System

HydroTurf® is a unique flexible concrete erosion prevention solution consisting of a high-friction, impermeable geomembrane layer with an integrated drainage layer overlain by an engineered synthetic turf. The geomembrane is placed directly on the subgrade soil. It is covered with the engineered turf whose fibers provide reinforcement for the HydroBinder® cementitious infill. This infill is placed dry to a thickness of ¾-inch minimum. After placement, it is then hydrated with a light spray of water. A cross section of HydroTurf® is shown in Figure 1.

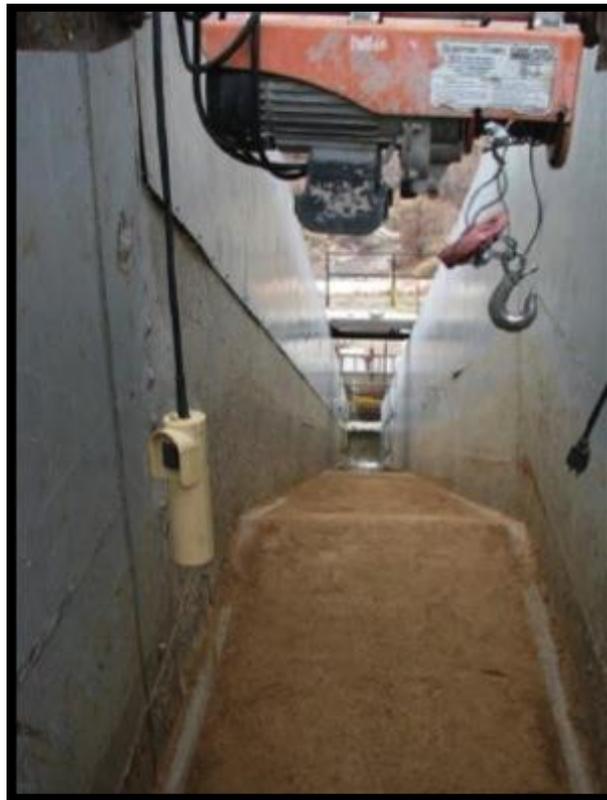
Figure 2 – Compacted Sandy-Loam Subgrade

HydroTurf® was installed in the flume in general accordance with Watershed Geosynthetics' installation guidelines. The flume is at a 2H:1V slope. First, a sandy-loam subgrade was compacted in place in the flume (See Figure 2). Next, a continuous sheet of the 50-mil structured geomembrane was placed with the "spike" side down (See Figure 3). This geomembrane serves as the underlayer of the system. Then, the engineered synthetic turf was placed on the geomembrane. A horizontal seam was placed in the synthetic turf layer near the bottom of the flume. The purpose of the seam was to test its strength under high flow velocity and shear stress conditions. This seam consists of two (2) sections of the synthetic turf which were heat-bonded together using similar equipment used for field installations. The next step in sample preparation was applying approximately a ¾-inch thick layer of dry HydroBinder® into the fibers of the synthetic turf. The dry mixture was placed using a drop spreader. It was broomed against the grain of the turf in order to pull the fibers up through the infill. The HydroBinder® infill was then hydrated by applying a light spray of water until saturation. The completed installation of the HydroTurf® System is shown in Figure 4.

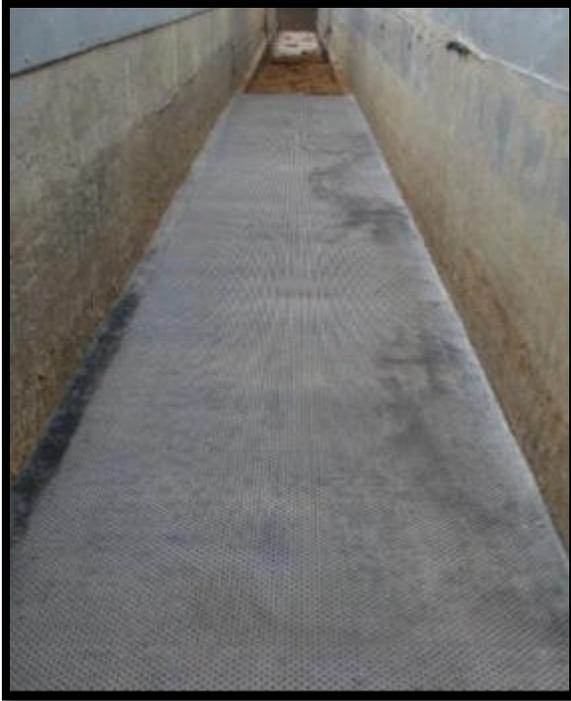
Figure 3 – Installation of the Structured Geomembrane

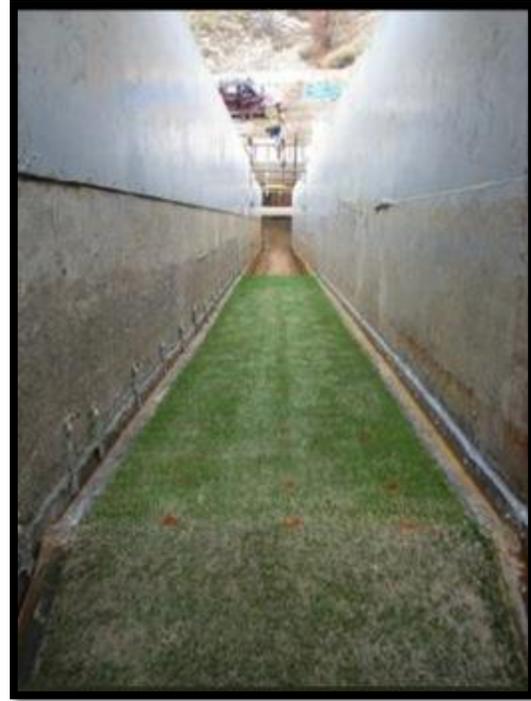
Figure 4 – Completed Installation of the HydroTurf® System

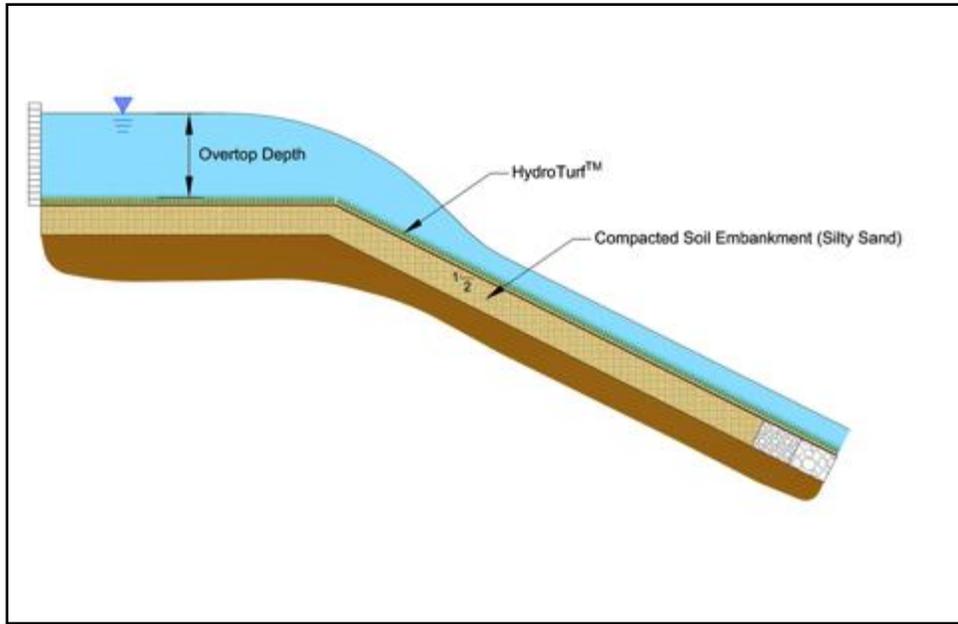
Figure 5 - Profile Section of the Installed HydroTurf® System in the Overtopping Flume

The HydroTurf® was tested at 1.5, 3, and 5-ft steady-state overtop depths for a total of 12 hours. After testing, the embankment flume was inspected. The system and underlying soil were determined to be intact. CSU reported stable performance values of 29.2 fps for velocity. Since no instability, deformation, loss of intimate contact or damage to the system occurred, and since no erosion of the underlying subgrade occurred; this value of velocity is not a maximum performance threshold. A summary of these results is shown in Table 1. A profile of the testing section is shown in Figure 5, and photographs of the testing are shown in Figure 6.

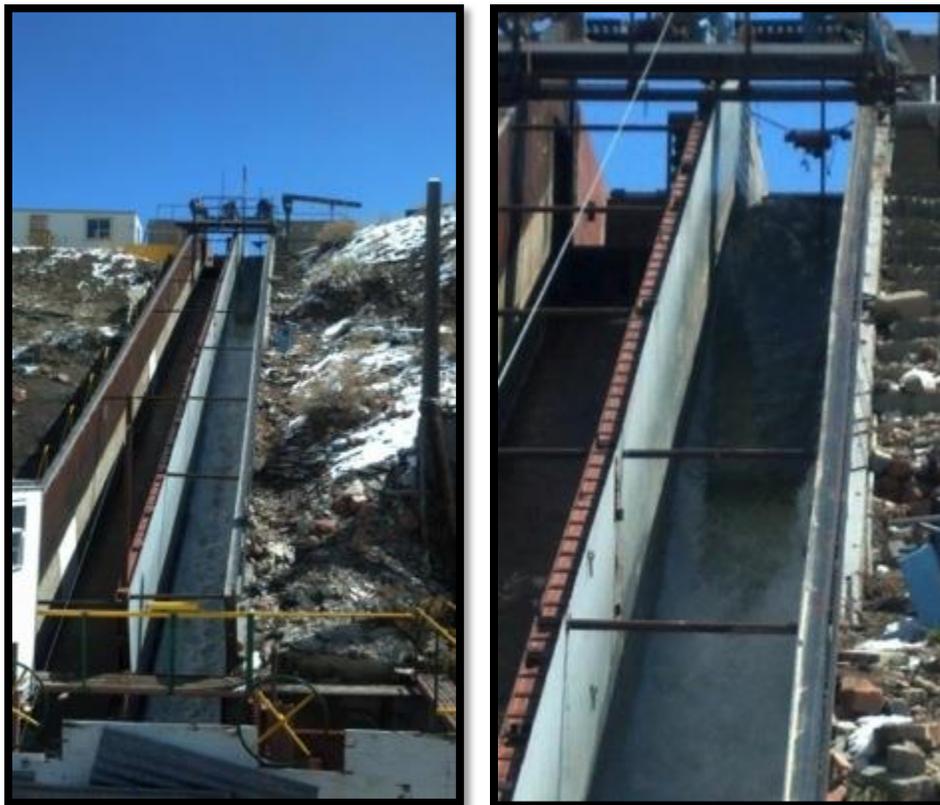
Figure 6 – Steady State Hydraulic Testing of HydroTurf® at CSU

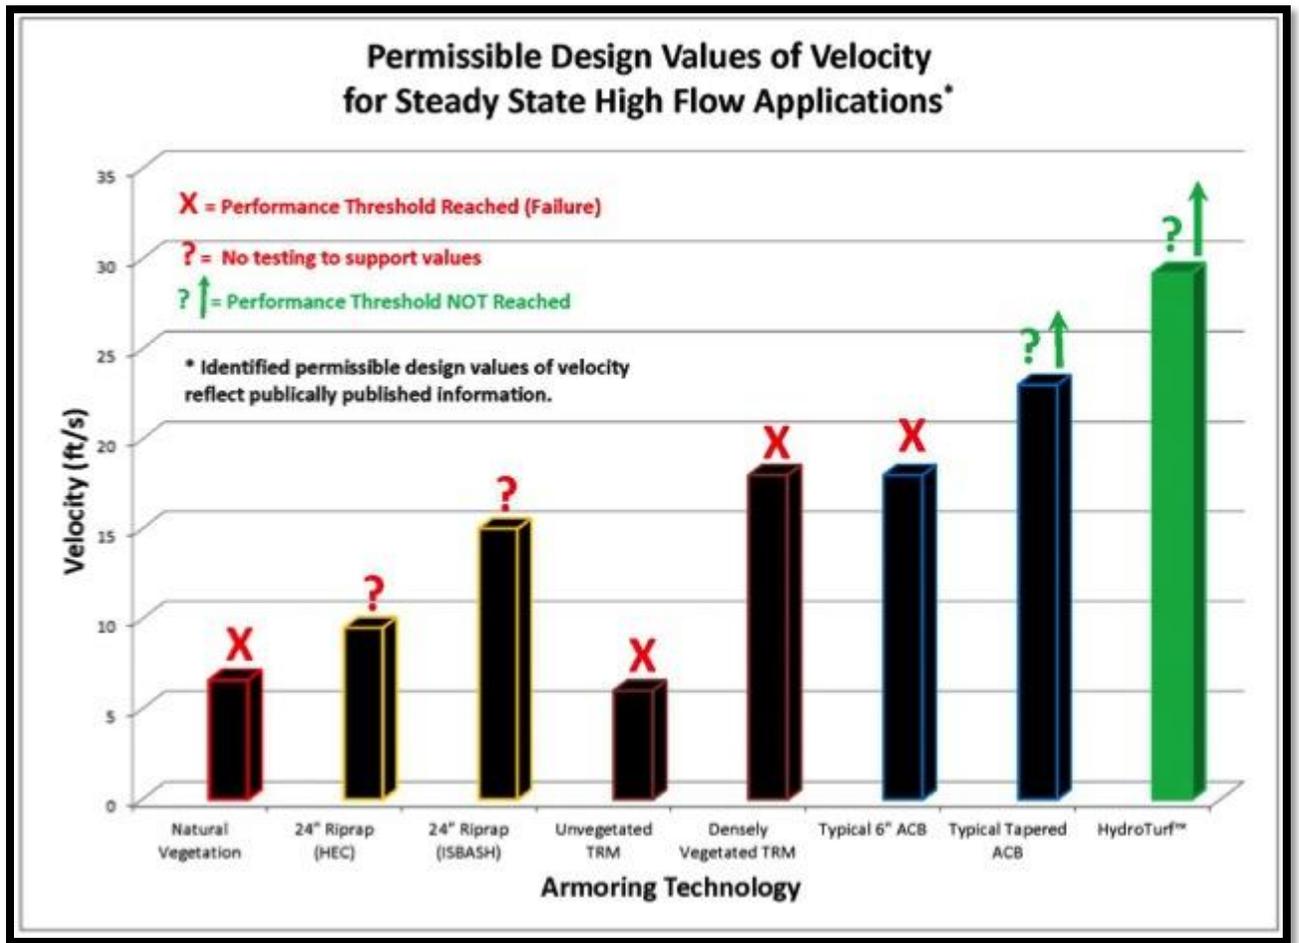
Figure 7 – Permissible Design Values of Velocity for Steady State High Flow Applications

The HydroTurf® performance value for velocity as measured in this steady state test is 29.2 fps at a 5-ft overtop depth. This value can be compared to the published maximum performance thresholds / permissible design values for various erosion and revetment technologies. This comparison shows that HydroTurf® outperforms these other systems (See Figure 7).

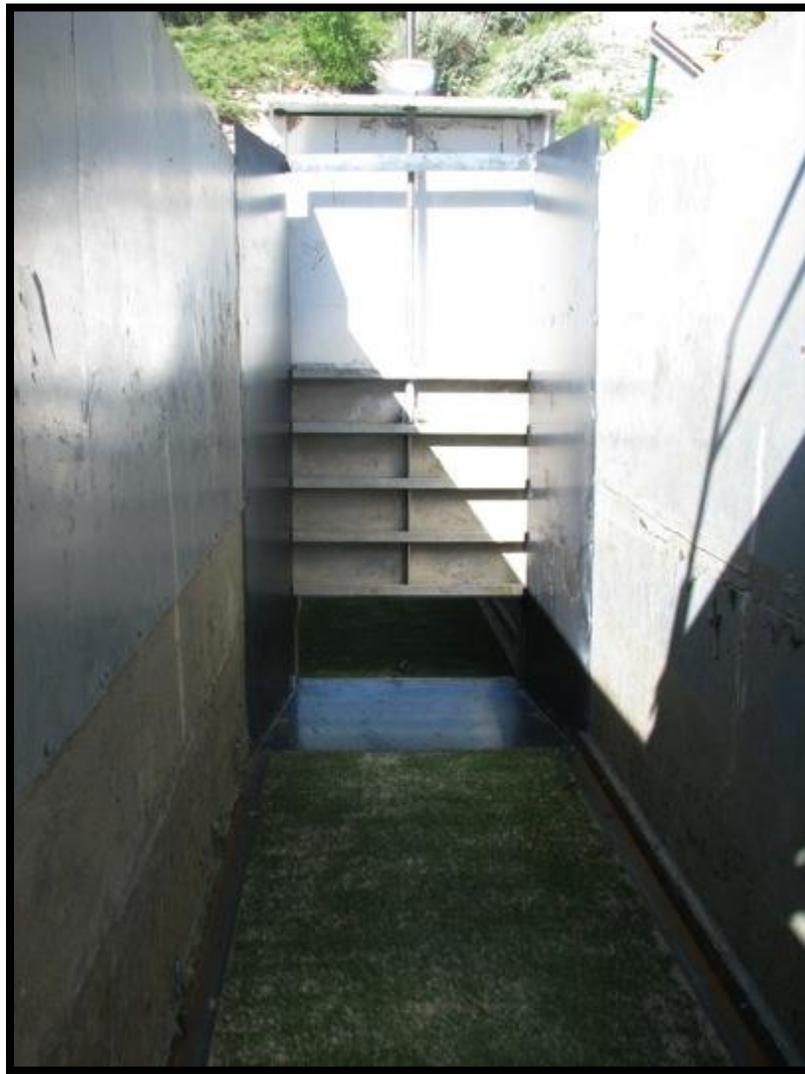
Figure 8 – Sluice Gate Installed in Overtop Flume for Hydraulic Jump Testing

Hydraulic Jump Testing - Since there is no standard test method for measuring hydraulic jump, CSU developed a test program that would adequately quantify the performance of the HydroTurf® under a series of hydraulic jumps. A manually operated vertical sluice gate was installed approximately 22 feet from the top of the embankment in order to create a hydraulic jump on the HydroTurf®. Figure 8 shows a picture of this sluice gate installed in the channel. This gate was set so that it created the jump on the lower third of the material in the flume. A profile section of the Hydraulic Jump test is shown in Figure 9.

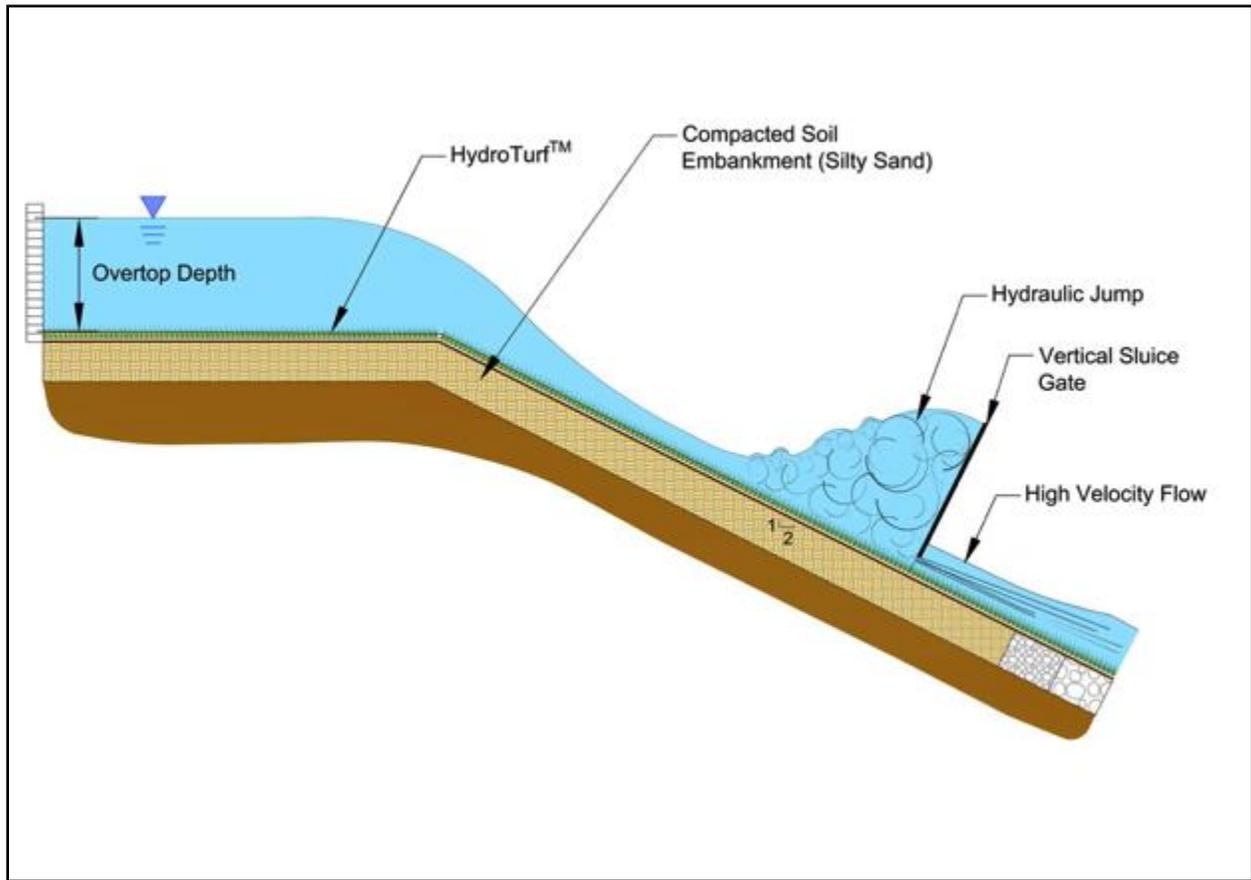
Figure 9 - Profile Section of the Installed HydroTurf® System in the Overtopping Flume for Hydraulic Jump Testing

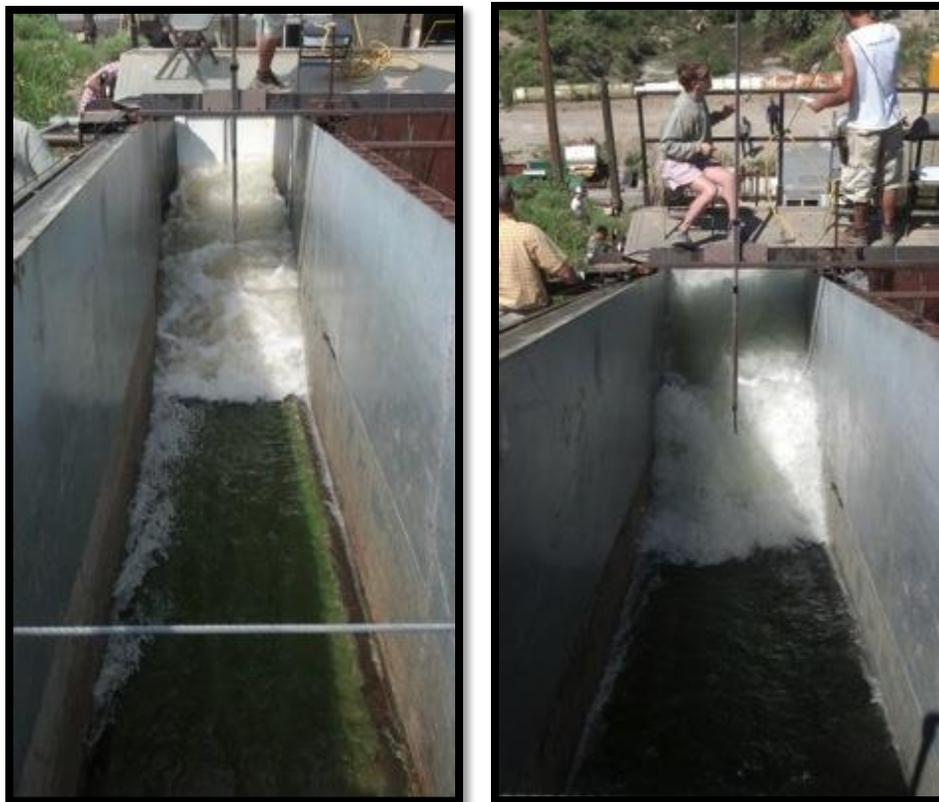
Figure 10 – Hydraulic Jump Testing of HydroTurf® at CSU

A test consisted of at least 1.5 hours of continuous flow at each discharge interval (1.5, 3.0, and 5.0-ft overtop depths). Measurements of water surface were taken at the gate, at the beginning of the jump and at approximate 2-ft intervals upstream along the centerline of the slope. After at least 30 minutes of flow under a hydraulic jump, the sluice gate was adjusted to move the jump upstream. The procedure was repeated to collect data for three (3) hydraulic jumps at each overtop depth. Photographs of the Hydraulic Jump Testing are shown in Figure 10.

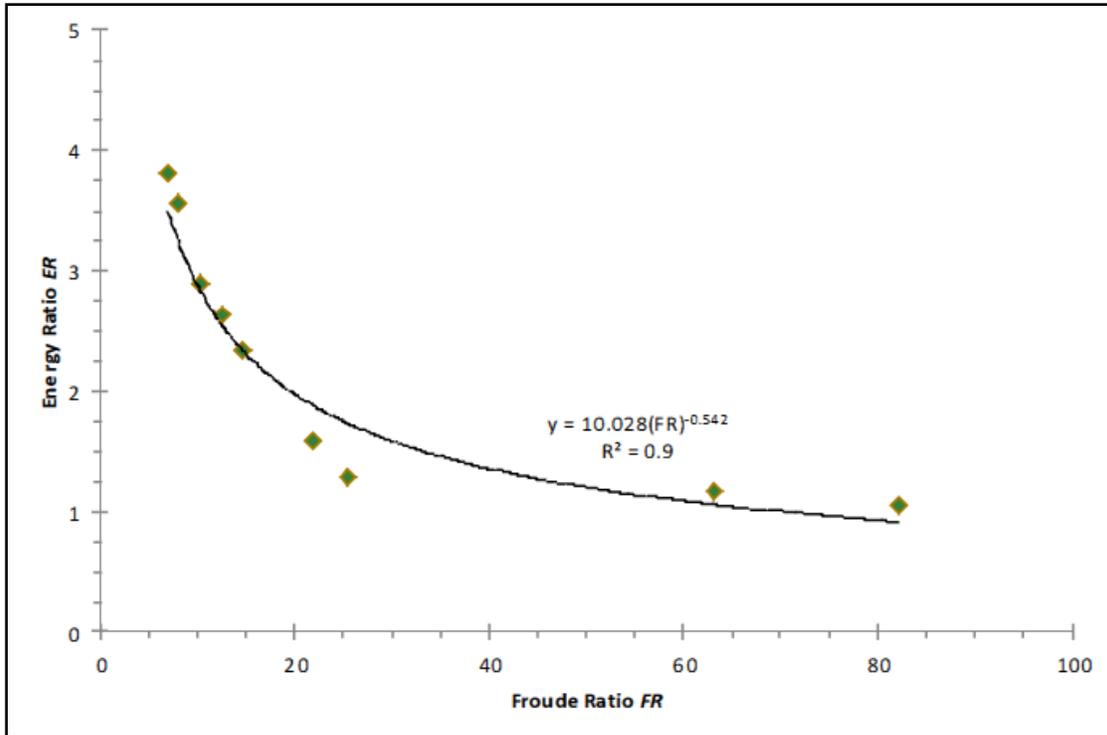
Figure 11 - Envelope Curve for Energy Ratio as a Function of Froude Ratio for HydroTurf®

The objective of the hydraulic jump test program was to quantify the performance of HydroTurf® under the hydraulic loading caused by a range of hydraulic jumps at various overtopping depths. A performance threshold was not reached since there was no instability, deformation, loss of intimate contact, or damage of the HydroTurf® system, and since there was no erosion of the underlying subgrade. However, a relationship between the energy lost in the jump and the ratio of the upstream and downstream Froude numbers was developed. This relationship is shown in Figure 11. Also, power dissipation was calculated for each hydraulic jump interval. It was plotted as a function of specific energy upstream of the jump (See Figure 12). The HydroTurf® System demonstrated the ability to withstand hydraulic loads caused by hydraulic jumps dissipating as much as 30 horsepower per foot of width.

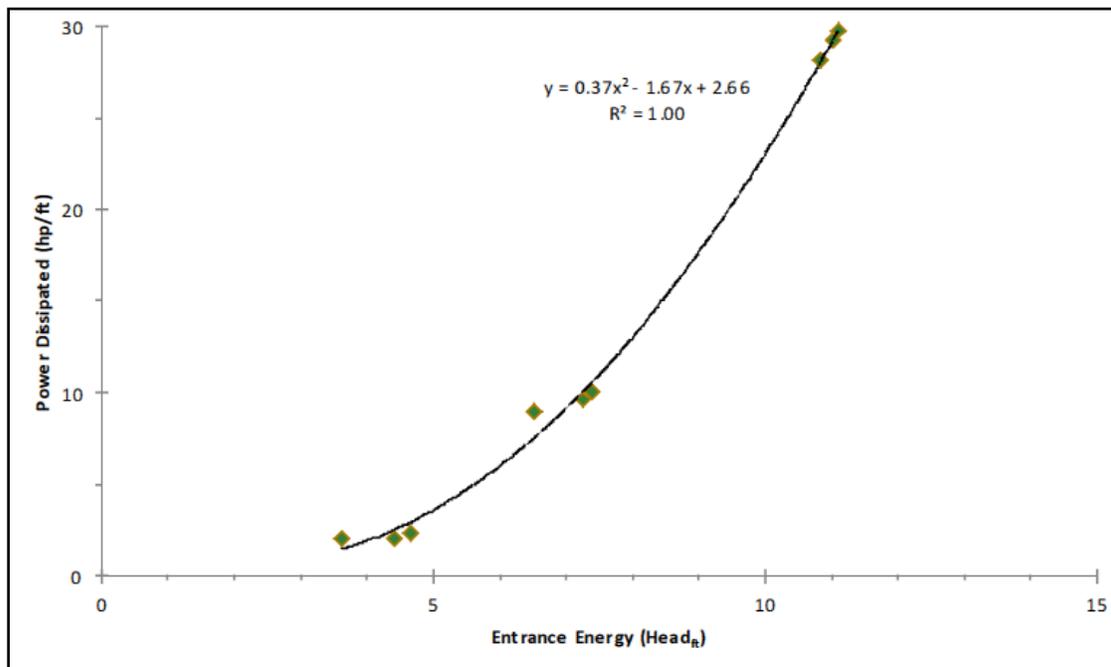
Figure 12 - Power Dissipation per Foot of Width as a Function of Specific Energy at the Entrance to the Hydraulic Jump for HydroTurf®

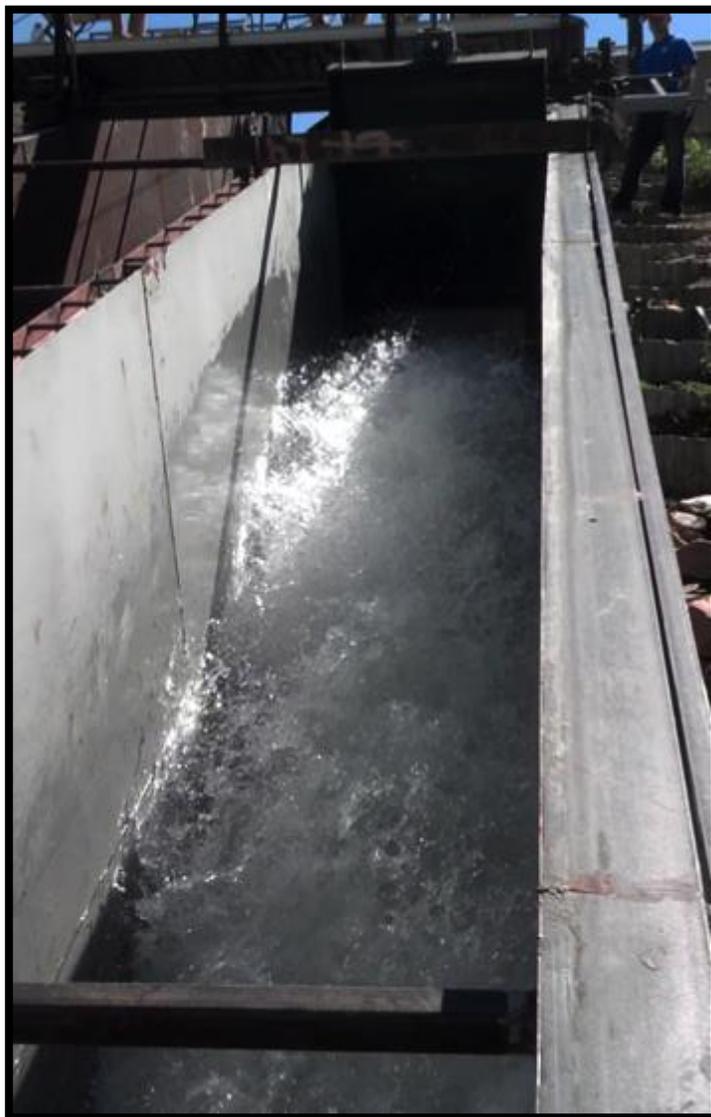
Figure 13 – Pressurized “Jet” from Under the Sluice Gate Surging onto the HydroTurf®

Since the sluice gate had a small opening at the base, the flow immediately downstream of it was a pressurized “jet” surging onto the HydroTurf® System. The extreme turbulence of the flow made it difficult to measure the velocity precisely, but the velocity of the jet of water exiting the hydraulic jump was approximately 35 fps. At the location of this jet, there was no instability, deformation, loss of intimate contact, or damage of the HydroTurf® system, and there was no erosion of the underlying highly-erodible subgrade. Figure 13 shows a photograph of the “jet” flow.

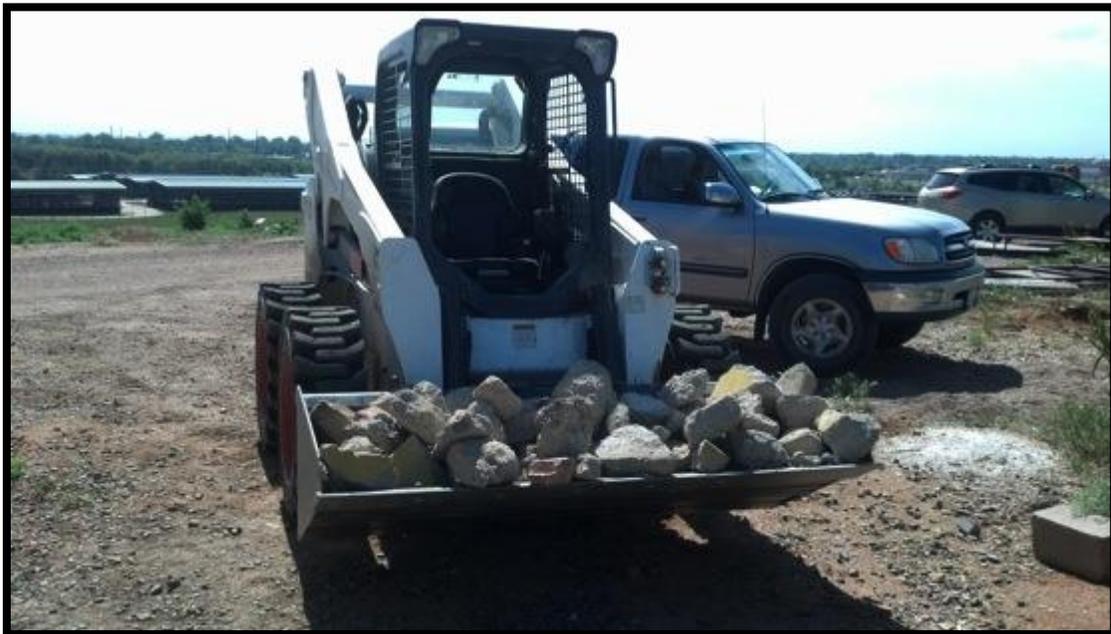
Figure 14 - Broken Concrete in Bobcat Bucket

The flow in the flume was brought to an overtopping depth of 5.0-ft. A Bobcat S850 front-end loader was filled with broken, angular concrete blocks ranging from approximately 3 to 15 inches in diameter (See Figure 14). The front-end loader dumped two (2) full buckets of concrete debris into the flume at the top of the embankment from a height of approximately 12 feet (See Figures 15 and 16). The concrete debris caused a few minor surface impressions at the location of the 12-ft drop. The integrity of the HydroTurf® System was not compromised. Also, there was no observed damage to the system downstream of the drop location. No instability, loss of intimate contact, or erosion was observed.

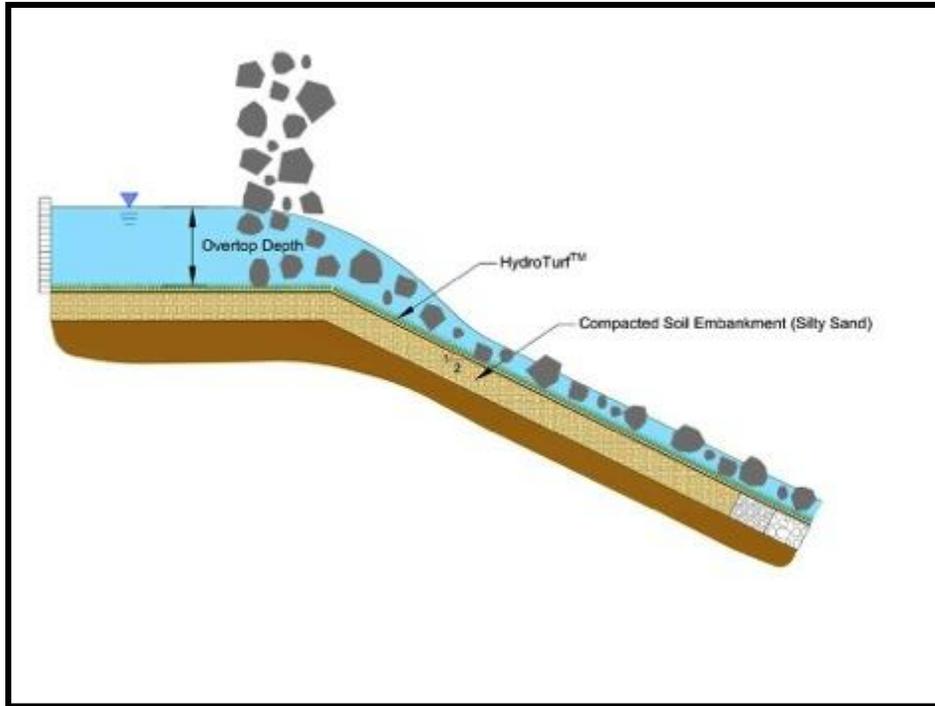
Figure 15 – Profile Section of Broken Concrete Being Dumped into the Flume

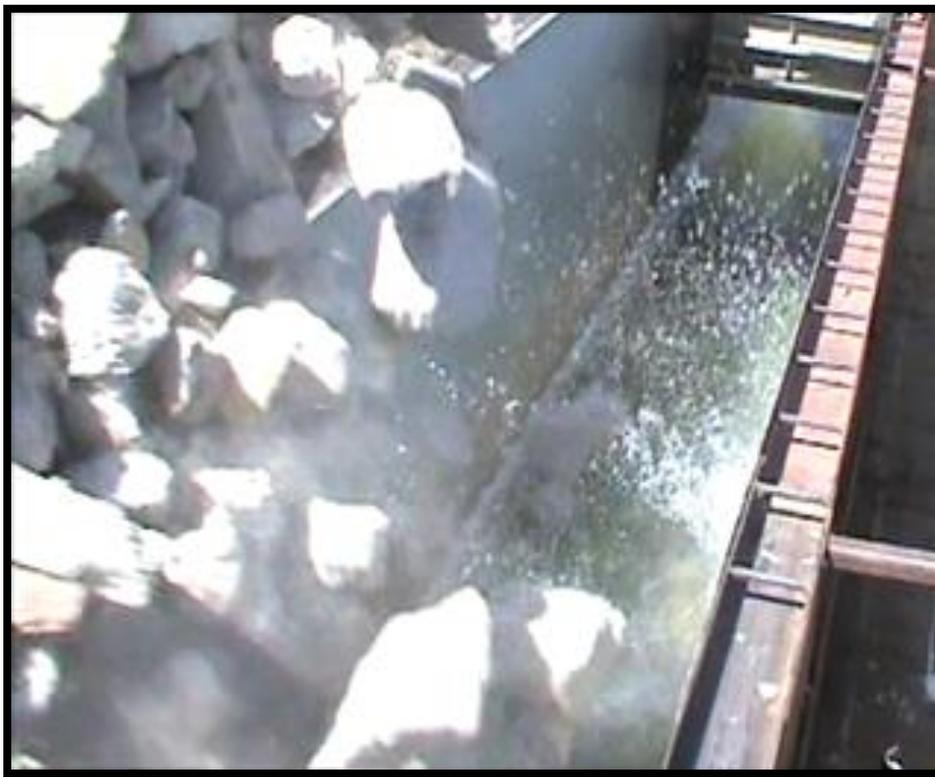
Figure 16 - Broken Concrete Being Dumped into the Flume

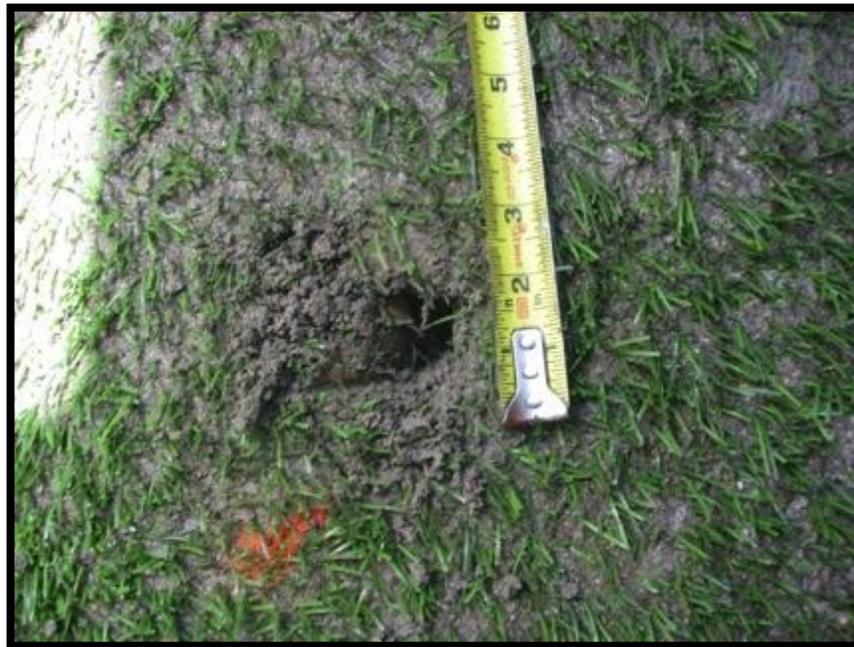
**Figure 17 - Intentional Damage: Hole from Pick Ax
(Prior to Testing)**

Intentionally Damaged State – The next test was designed to evaluate the performance of the HydroTurf® System in a damaged state. A pick axe was intentionally driven through the HydroTurf® system and approximately 6-in into the underlying sandy-loam subgrade. Figure 17 shows a photograph of this hole. Testing was performed at the 3-ft and 5-ft overtop depths for a duration of 1 hour at each overtop depth (total of 2 hours).

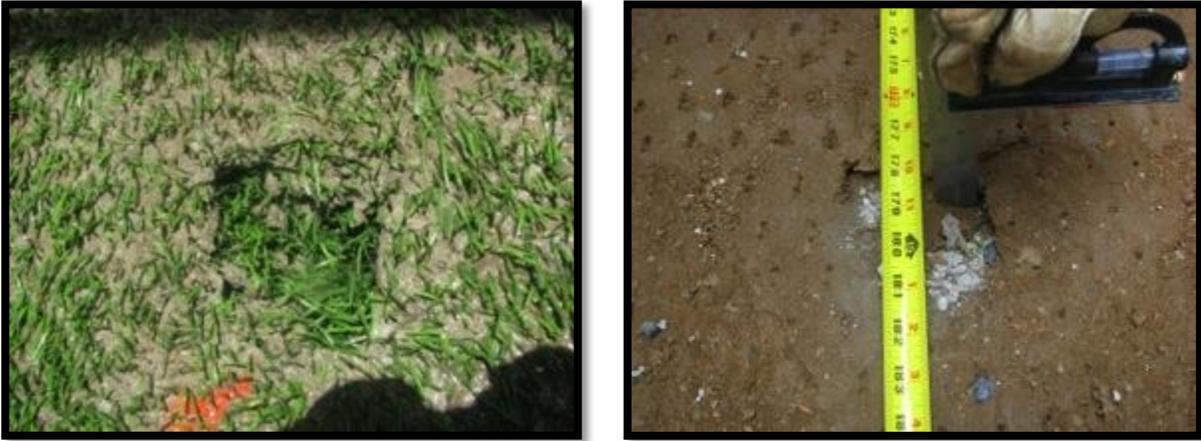
**Figure 18 - Intentional Damage: Hole from Pick Ax
(After Testing)**

No instability or discernible erosion was observed. After removal of the HydroTurf® System, the subgrade was inspected. There was no erosion, and the initial hole closed. Also, the subgrade along the entire embankment showed no signs of erosion. Figure 18 shows a photograph of the intentional hole at the conclusion of testing and a photograph of the subgrade at the location of the hole after the system was removed.

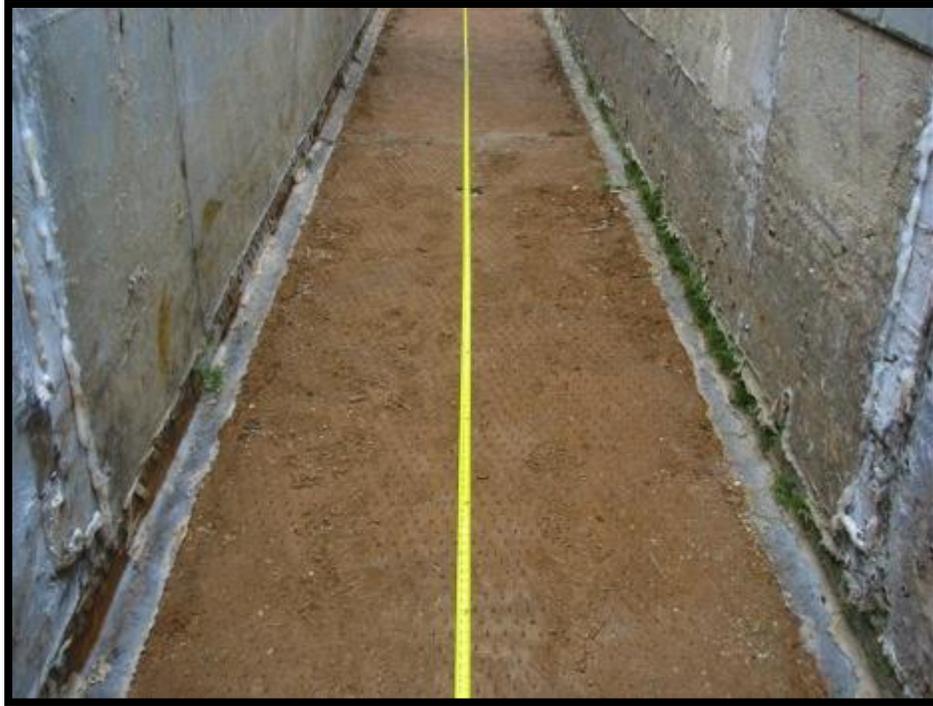
**Figure 19 – Condition of the Soil Subgrade
(After Testing and Removal of HydroTurf® System)**

Full-scale hydraulic performance testing of the HydroTurf® Revetment Technology was completed at CSU in the steady state overtopping flume. Testing was conducted in accordance with standard procedures for ACB revetment system testing. HydroTurf® was tested in steady state flow conditions for a total of 20 hours under various events. HydroTurf® was able to withstand hydraulic loads resulting in a velocity exceeding 29.2 ft/s at a Manning's n value of 0.020. The test program has also demonstrated the ability of the system to withstand hydraulic loads caused by hydraulic jumps dissipating as much as 30 horsepower per foot of width. The qualitative tests demonstrated the ability for the HydroTurf® System to withstand impact and abrasion caused by large debris, as well as to withstand damage associated with puncture. Instability or failure of the system did not occur, and erosion of the subgrade did not happen. Therefore, the HydroTurf® Revetment System was not tested to its performance threshold. A photograph of the condition of the soil subgrade post-test is shown in Figure 19.

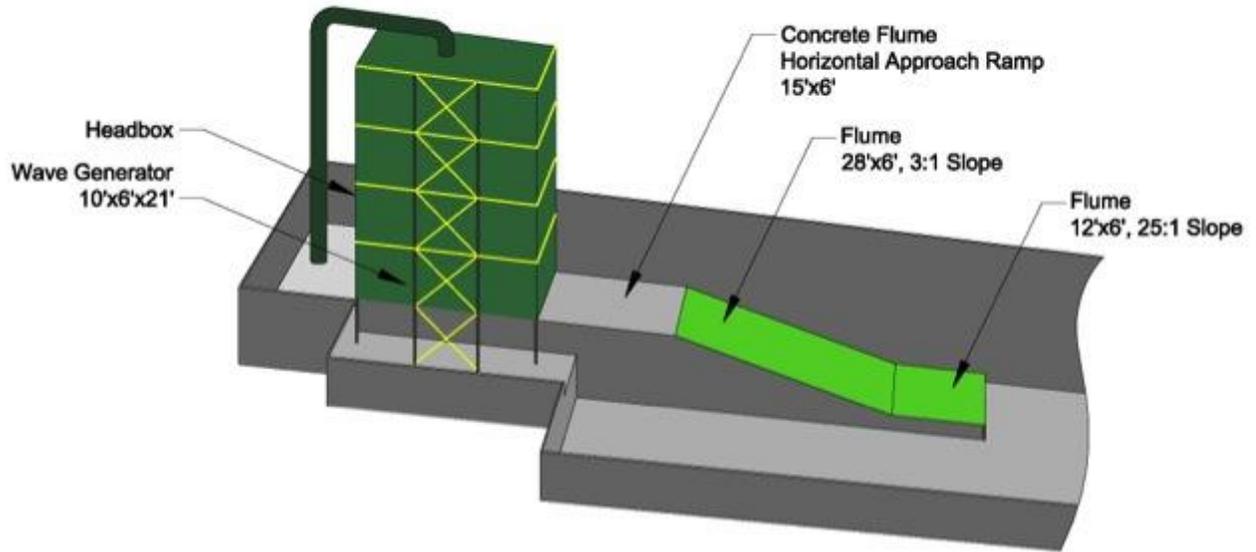
Figure 20 – Schematic of the CSU Wave Overtopping Test Facility

Full-scale Wave Overtopping Tests for Levee Landward Side Slope Protection were performed on HydroTurf® at CSU. Testing was performed in accordance with the methodology developed for the US Army Corps of Engineers. A schematic and a photograph of the wave overtopping simulator facility are shown in Figures 20 and 21, respectively.

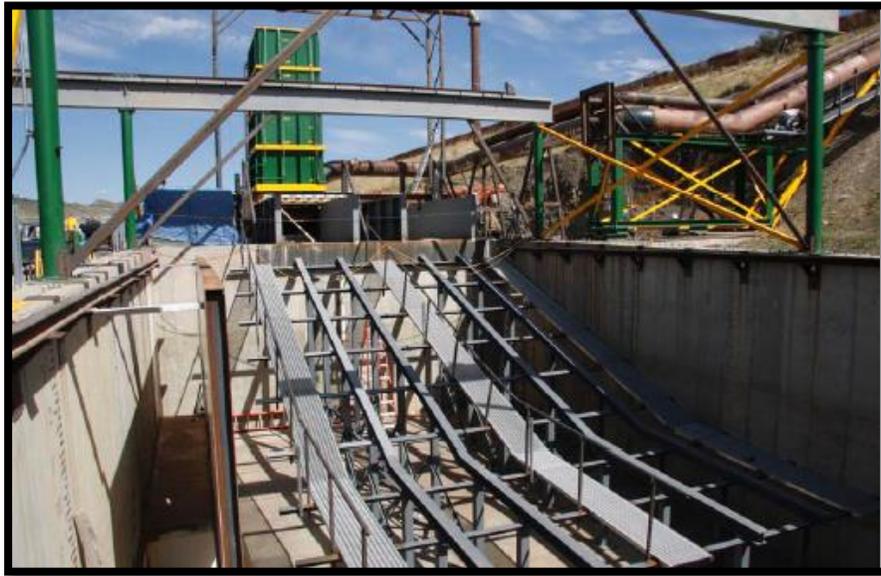
Figure 21 – CSU Wave Overtopping Test Facility

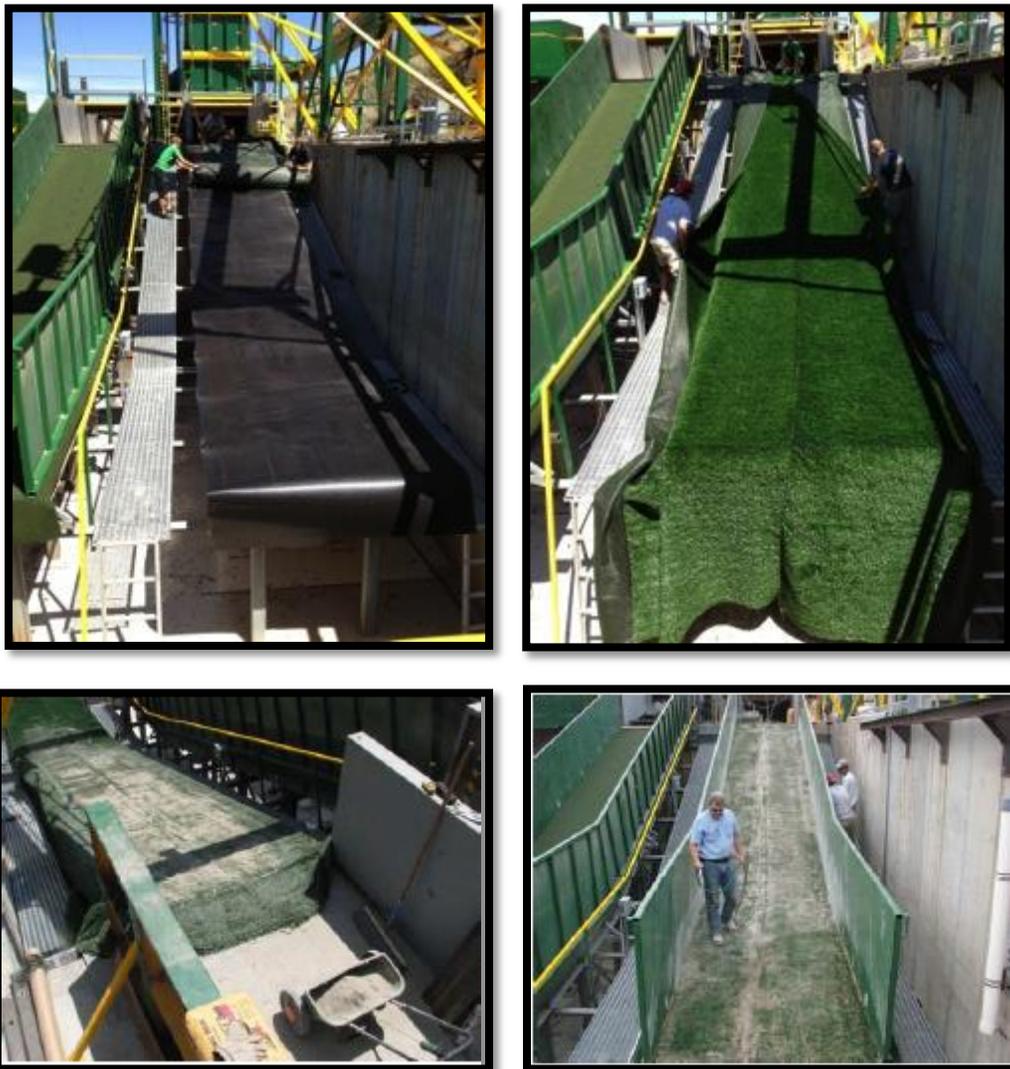
Figure 22 – Installation of the HydroTurf® System

The HydroTurf® was installed on the soil in the trays. First, a continuous sheet of the 50-mil structured geomembrane was placed with the “spike” side down. This geomembrane serves as the underlayer of the system. Then, the engineered synthetic turf was placed on the geomembrane. One of the primary purposes of the experiment

was to test the strength of the sewn seam between two adjacent pieces of the synthetic turf component. Two (2) sections of the synthetic turf were sewn together using a similar machine used for field installations. This joined piece was placed on the trays so the seam was situated along the down-slope centerline of the trays. The next step in tray preparation was applying approximately a ¾-inch thick layer of dry HydroBinder® infill into the fibers of the synthetic turf. The dry mixture was placed using a drop spreader, and then it was broomed against the grain of the turf in order to pull the fibers up through the infill. The HydroBinder® mix was then hydrated. Installation photos are shown in Figure 22.

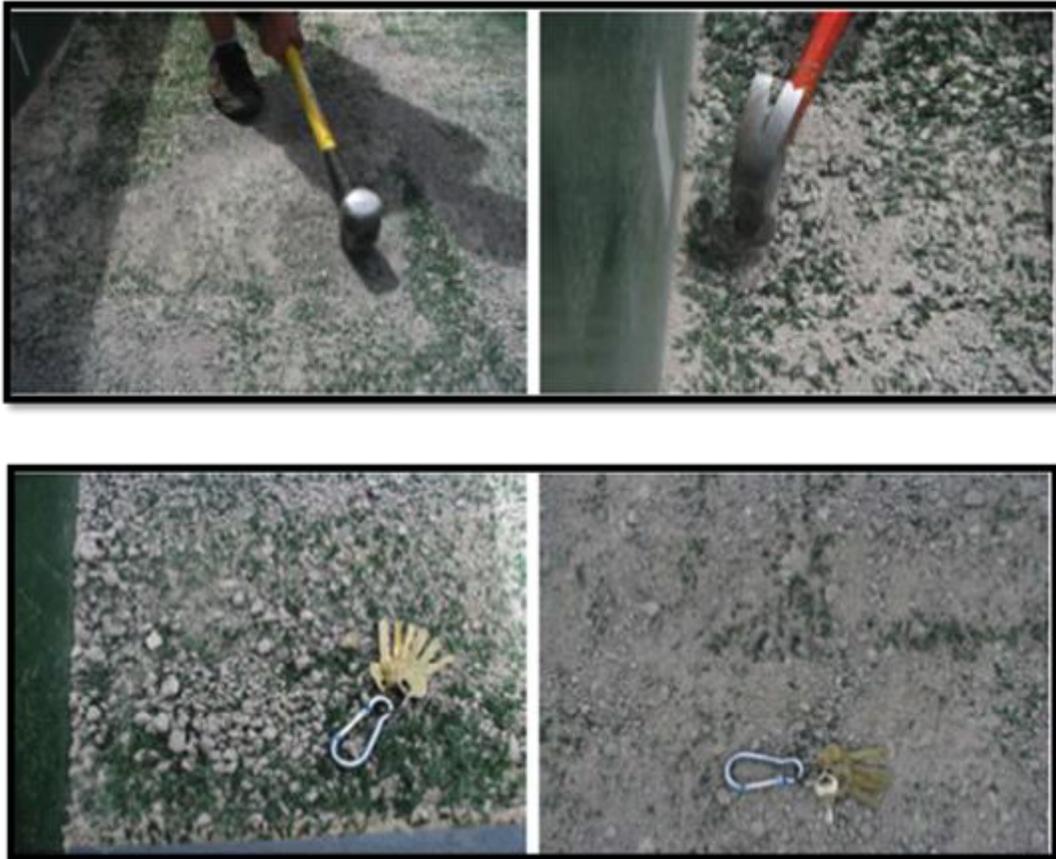
Figure 23 – Intentional Damage: Pulverization of HydroBinder® Infill

- Phase 2 - Pulverization of the hardened HydroBinder® infill in order to simulate cracked mortar and portions of the surface that had been severely damaged. (See Figure 23)

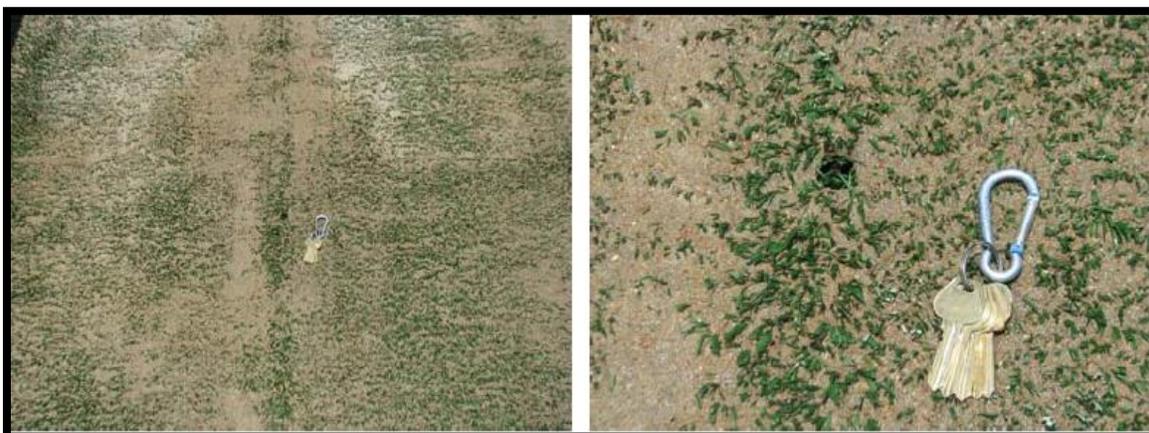
Figure 24 – Intentional Damage: Simulated Bullet Hole through HydroTurf®

- Phase 3 - A bullet hole was simulated by driving rebar through the HydroTurf® into the underlying subgrade. (See Figure 24)

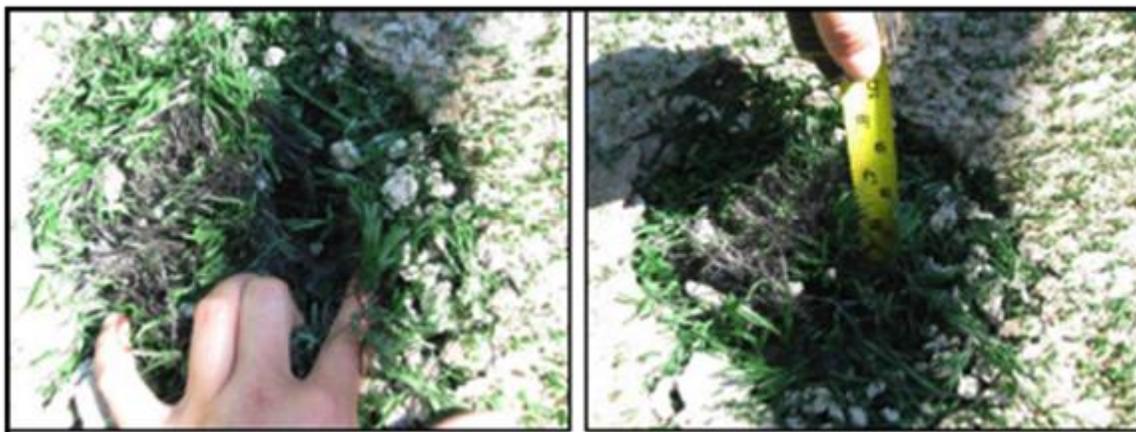
Figure 25 – Intentional Damage: Large Hole through HydroTurf®

- Phase 4 - A larger hole was created using a pick axe to expand the simulated bullet hole. This larger hole was approximately 4-inch diameter and 7-inches deep. (See Figure 25)

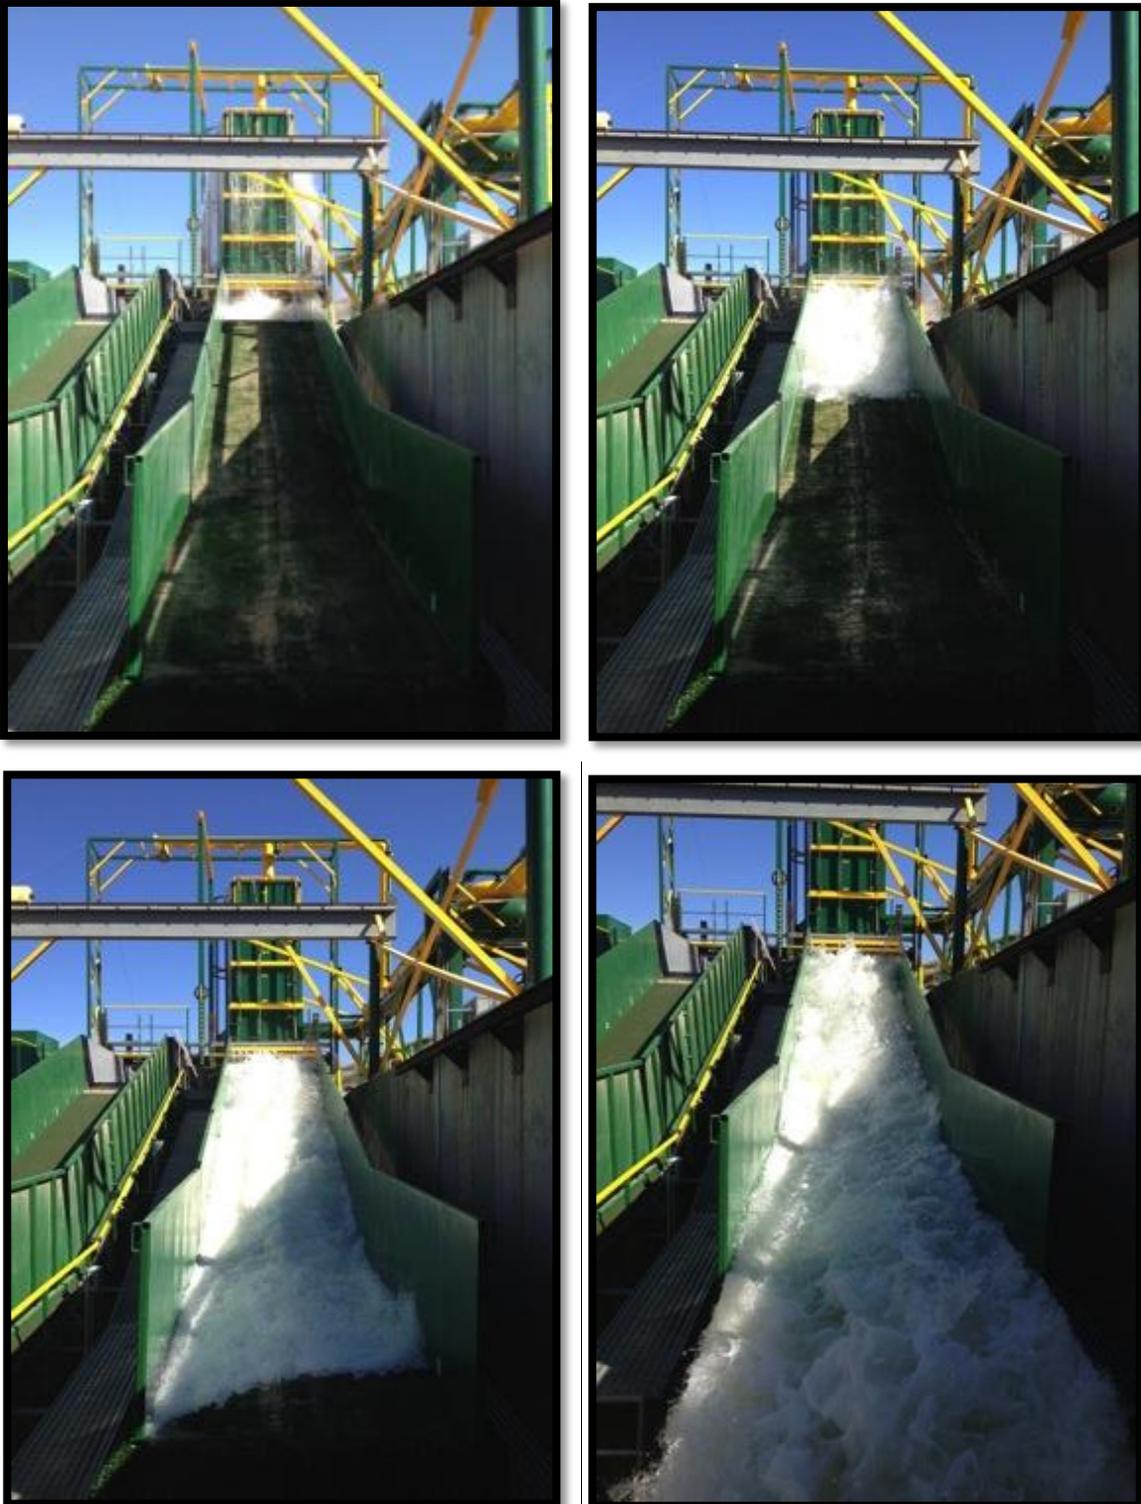
Figure 26 – Wave Overtopping Testing of HydroTurf® at CSU

Photos of the testing are included in Figure 26.
