TECHNICAL NOTE

FULL-SCALE HYDRAULIC TESTING OF THE HYDROTURF® ADVANCED REVETMENT TECHNOLOGY

Extensive independent, 3rd party hydraulic testing has been performed at Colorado State University – Engineering Research Center (CSU) in Fort Collins, CO on the HydroTurf® Revetment System. This technical note describes the full-scale testing that was completed. The information presented in this technical note is as follows:

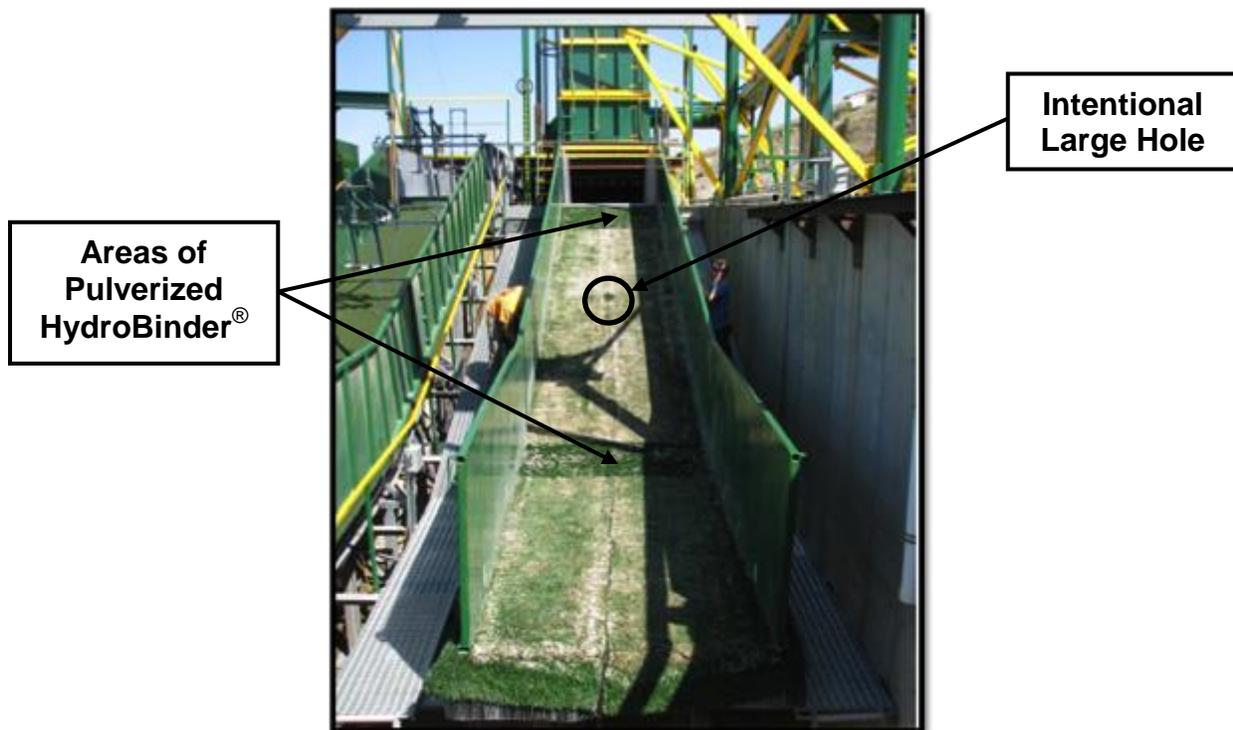
Figure 27 – Condition of HydroTurf® System after Completion of Wave Overtopping Testing

Upon completion of the tests, the HydroTurf® was removed and the underlying soil condition was documented. The HydroTurf® Revetment System performed well in maintaining the underlying, highly-erodible soils during these severe conditions, even in an intentionally damaged state. Figure 27 is a photograph of the condition of the HydroTurf® System after the 13 hours of testing. Figure 28 is a photograph of the condition of the highly-erodible, silty sand subgrade which was underneath the HydroTurf®.

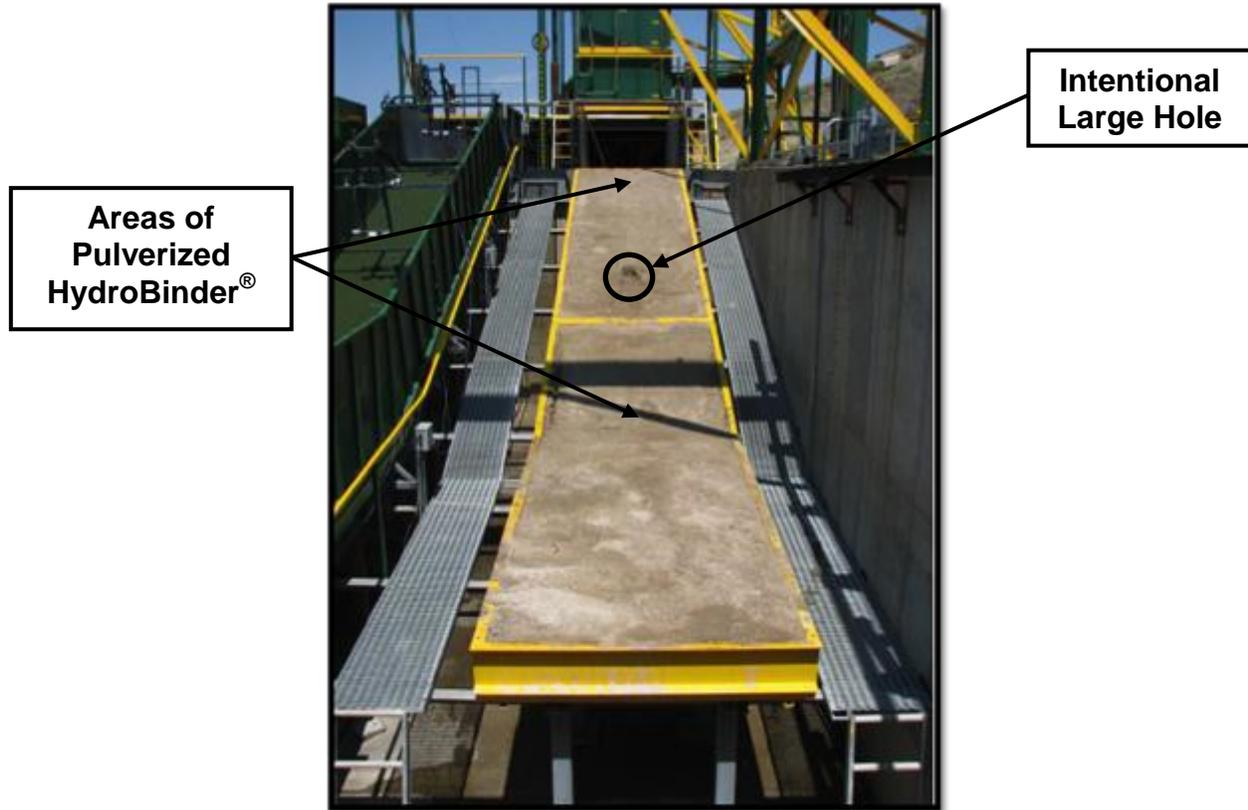
Figure 28 – Condition of Silty Sand Subgrade after Completion of Wave Overtopping Testing

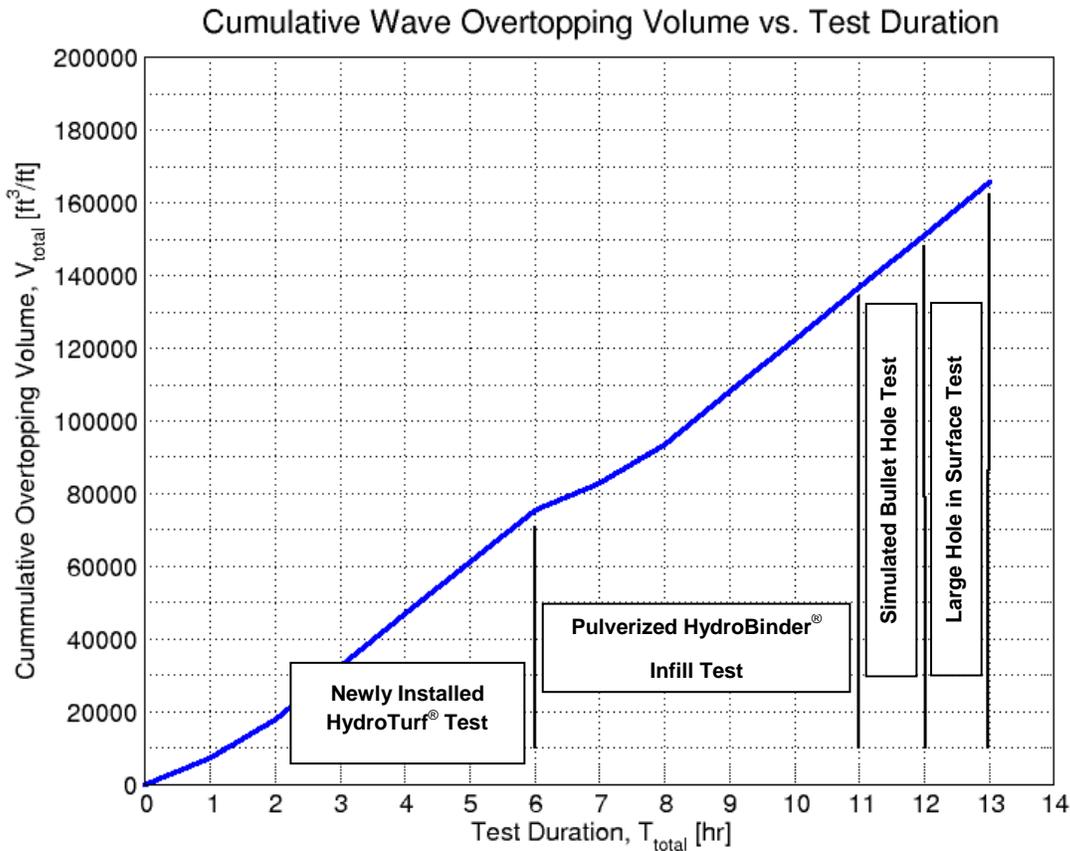
Figure 29 – Cumulative Wave Overtopping Volume vs. Test Duration for HydroTurf®

- The field sewn seam adjoining the adjacent panels of engineered turf proved successful throughout the high stresses exerted during the 13 hours of testing.
- A graph of Cumulative Wave Overtopping Volume vs. Test Duration is shown in Figure 29.

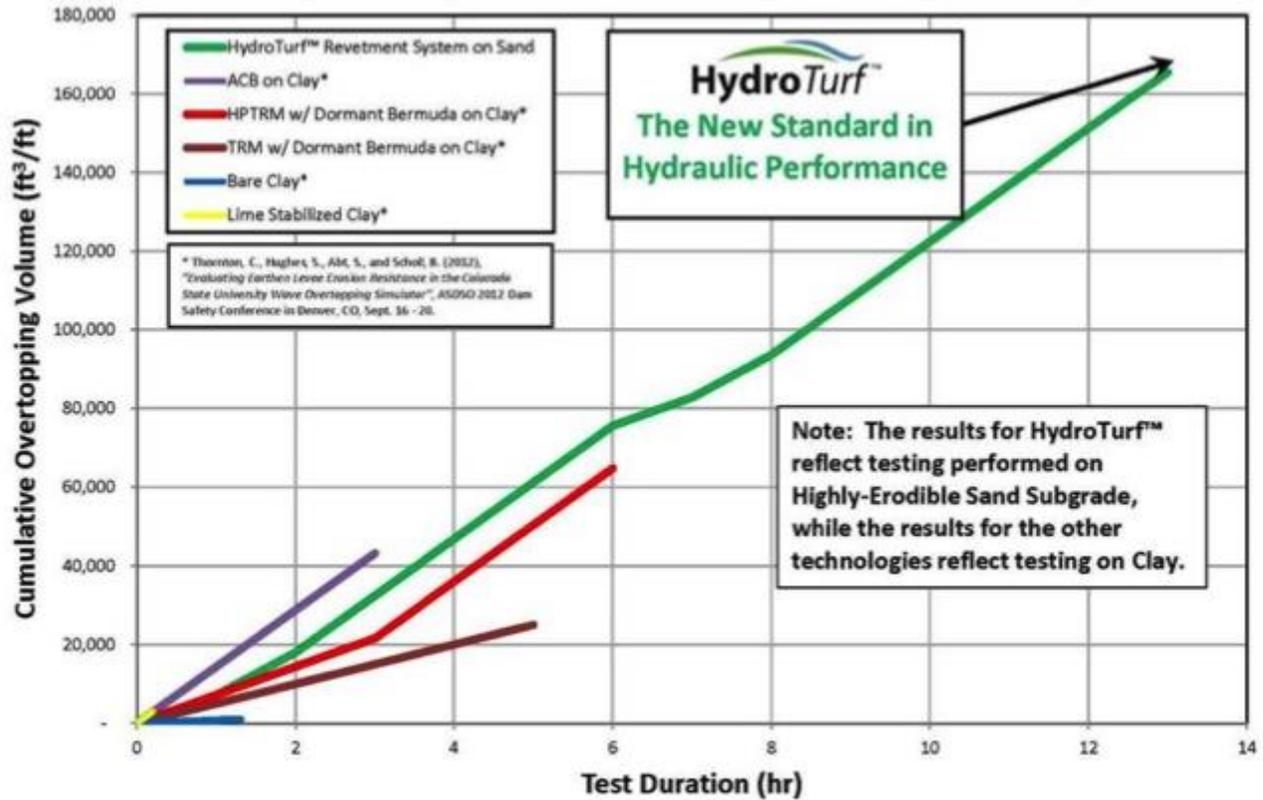
Figure 30 – Armoring Performance for Levee Landward-Side Protection from Wave Overtopping

The performance of HydroTurf® in the wave overtopping simulator can be compared to the performance of other erosion control technologies. The graph in Figure 30 shows a comparison of armoring performance for levee landward-side protection for various technologies which have been tested in the CSU Wave Overtopping Simulator. HydroTurf® outperformed these other systems. Also, note that the subgrade for the other technologies was clay while the subgrade for the HydroTurf® was highly-erodible silty sand.
