NUSTAR ENERGYPIPELINE CROSSING

West Monroe, LA

HydroTurf® CS

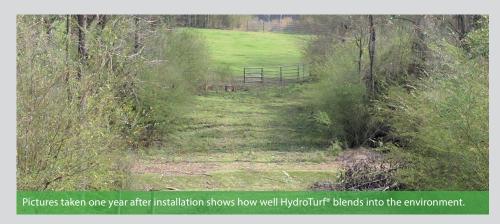
The site, located in the city of West Monroe, is a perennial stream that has continuous flow in parts of its stream bed all year round. During heavy rain, the stream reaches full capacity with high water velocities passing through. The culmination of past events eventually washed out the sandy, highly erosive soil and exposed the gas pipe that crossed through the site. This exposure put the pipe at risk for potential damage. NuStar sought a permanent restoration measure that would hold up to the site conditions and protect the pipe integrity over the long term. They chose HydroTurf because of its ability to permanently cover the stream bed so that water could not penetrate and erode through the subgrade to the piping underneath.

In order to repair the site, the stream was regraded to completely cover the pipe. Once contoured, the membrane, engineered turf and HydroBinder® cementitious infill were installed over a one-day period with lightweight equipment, which is especially important to a site with limited access.
